PROPERTY CONDITION ASSESSMENT

America's Best Value Inn & Suites 22127 Highway 99 Edmonds, WA 98026

September 6, 2022

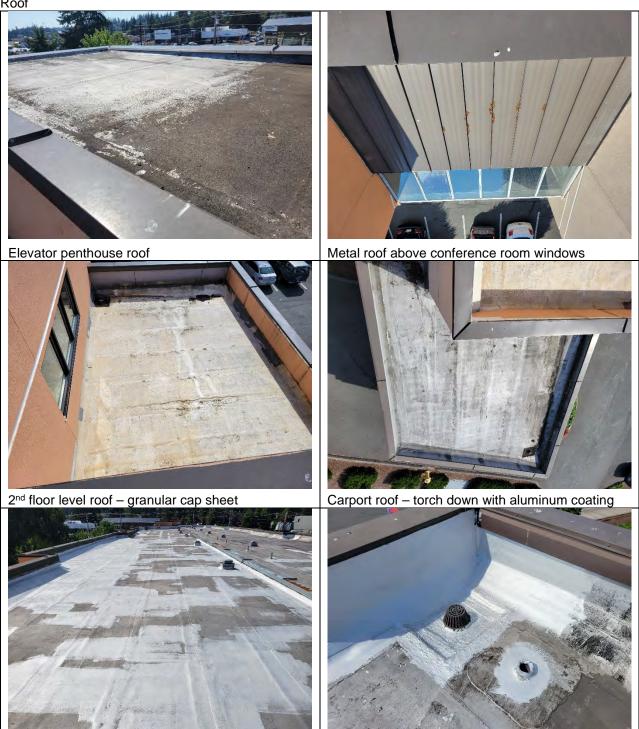
Torch down roof - looking west

Drain and penetration repairs

Replace the roof
