2023 Annual Bridge Report

Prepared by: Snohomish County Public Works
Engineering Services Bridge Group

Submitted: April 2024

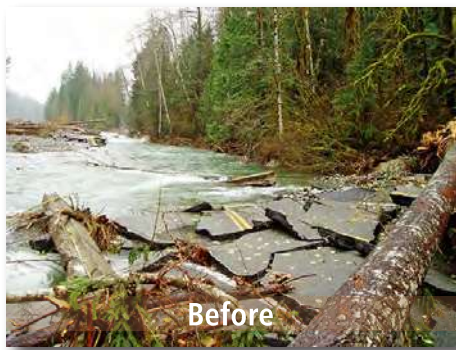
Looking upstream at the flood damaged Index-Galena Road near mile 6.9 in 2006.

During a storm in 2006, the North Fork of the Skykomish River carved a new side channel that damaged Index-Galena Road between miles 6 and 7. In addition to relocating one mile of road above the river, the project built the new Bridge 673 at the upstream end of the project near mile 7. In November 2023 the county celebrated the re-opening of Index-Galena Road.

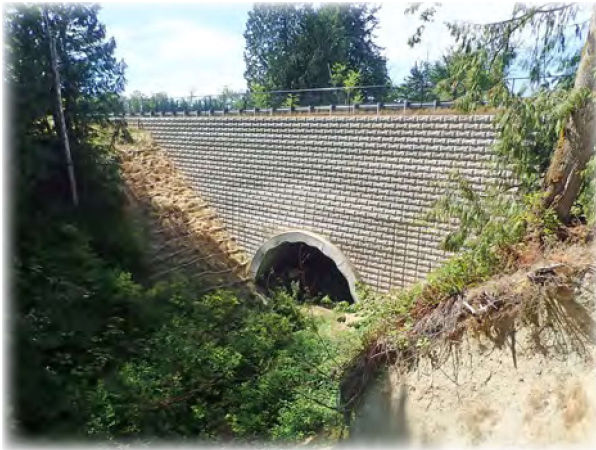
Woods Creek Vista B 682 is a developer-built corrugated steel arch culvert spanning 32 feet over an unnamed creek in a new housing development just northeast of Monroe.

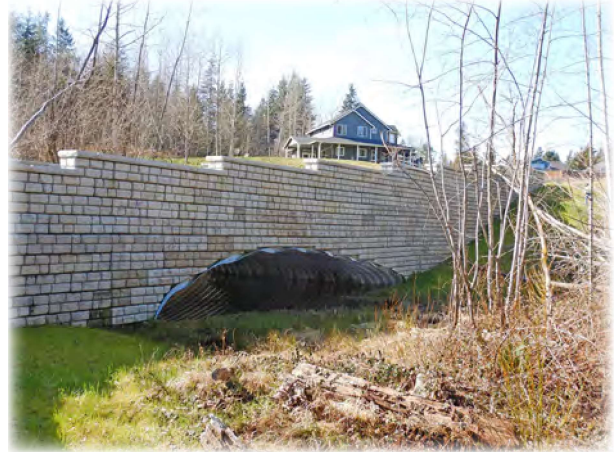
Reiner Bluff 675 is a developer-built corrugated steel arch culvert spanning 54 feet over a wetland on 120th St. SE just northwest of Sultan.

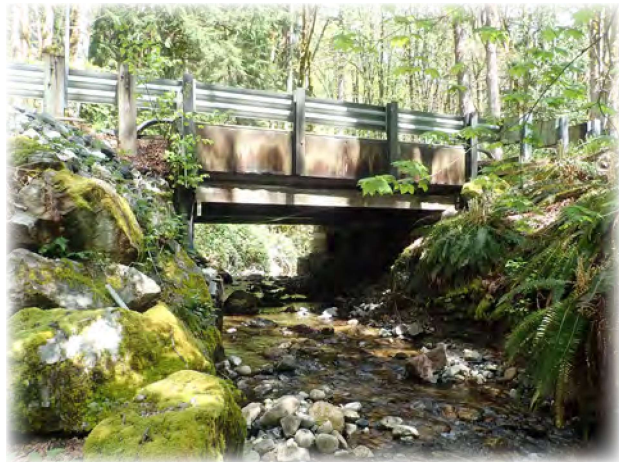
Hogarty Creek Bridge 636 on Reiter Rd in Sultan is a short span built in 1997. It’s an example of one of our bridges that is a combination of wood and concrete construction.

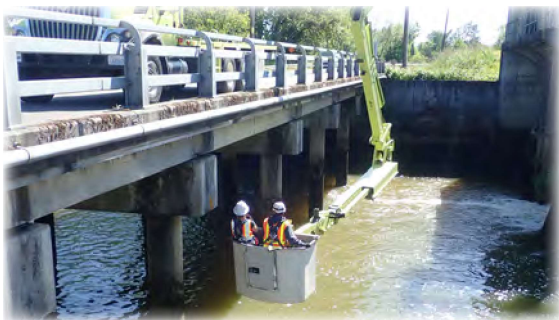
County and WSDOT inspectors looking at the girders and substructures of a City of Everett bridge from the UBIT.

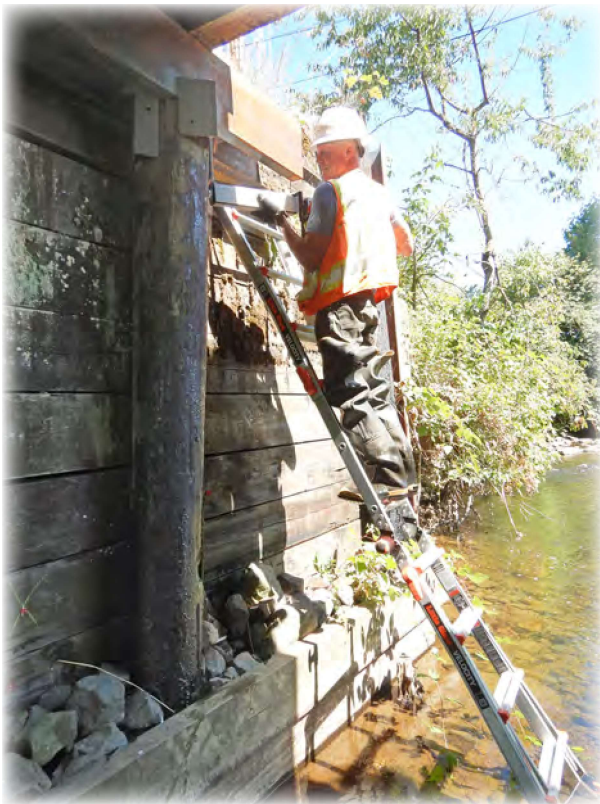
County bridge inspector drilling a timber pile at Bridge 443 to evaluate the condition and detect any decay.

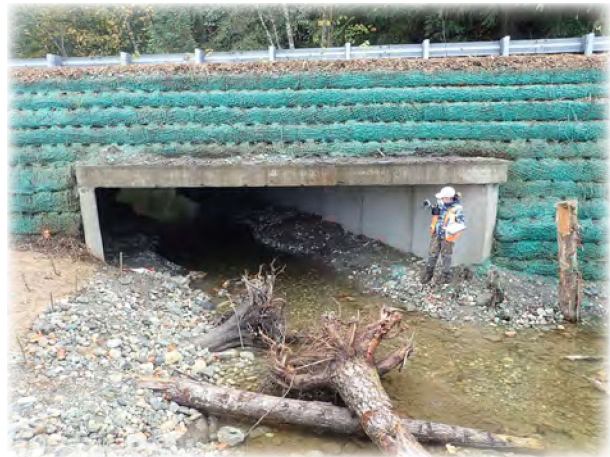
County bridge inspector performing the initial inspection of a new culvert on Mann Road.

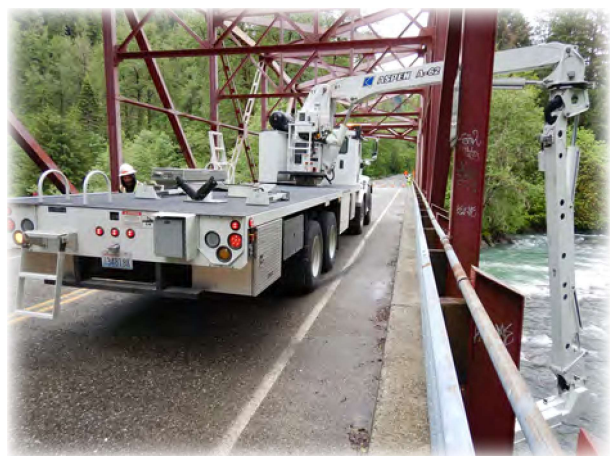
Red Bridge 537 on the Mountain Loop Highway. County and WSDOT inspectors are inspecting the bridge's steel truss via a WSDOT UBIT.

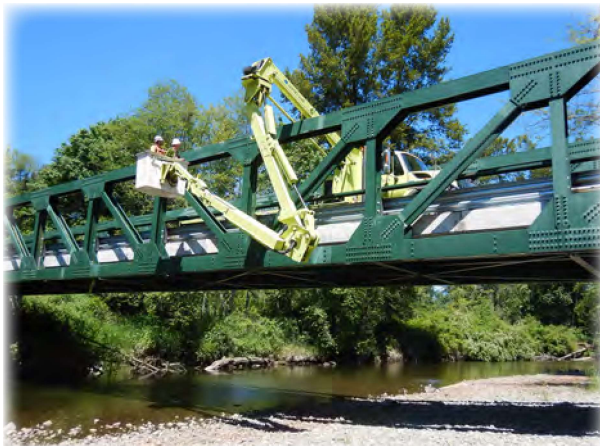
County and WSDOT Inspectors in UBIT conducting the NSTM inspection on Pilchuck River Bridge 581. All steel tension members are required to be inspected at hands length.

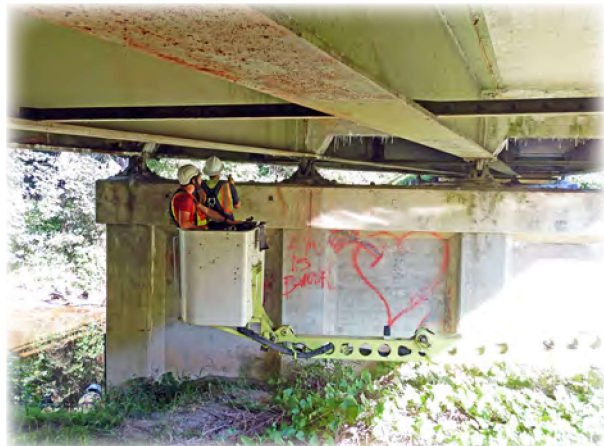
Pilchuck Creek Bridge 626, built in 1933, requires a Special Feature Inspection of the steel pins every 72 months. Ultrasonic Testing (UT) equipment provides an effective, non-destructive method to assess the condition of steel members.

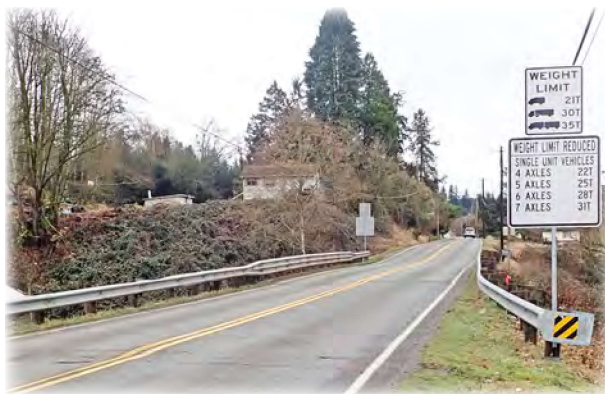
Cattle Pass Bridge 183 on Lowell-Larimer Road has new weight limits posted.

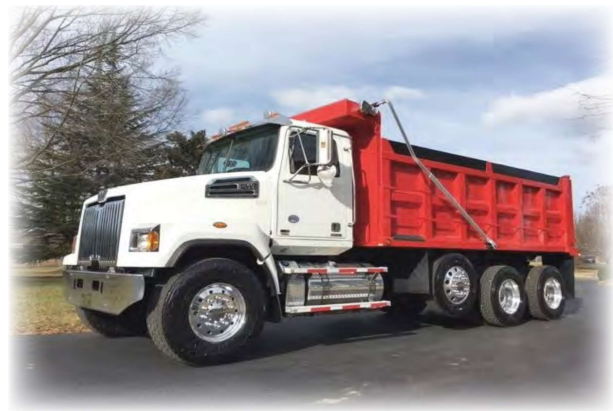
Example of a SU4.

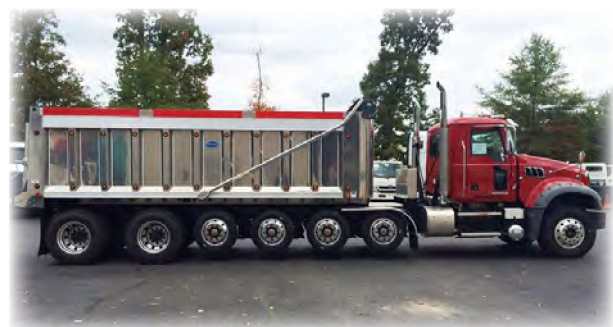
Example of a SU7.

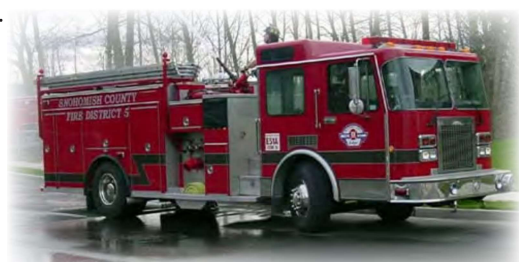
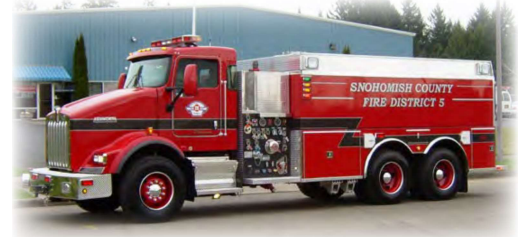
Example of an EV2 (above) and EV3 (below).

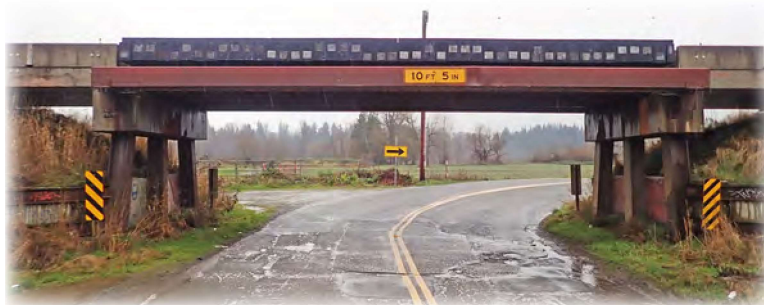
Norman Road Underpass is height restricted. Snohomish County conducts a Safety Inspection of this BNSF steel and concrete bridge constructed in 2013 near Stanwood.

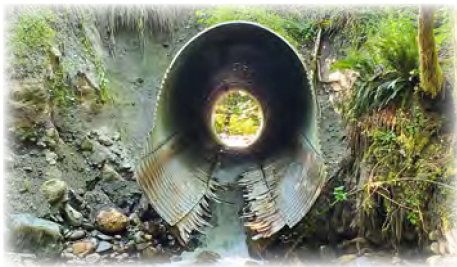
Goodman Creek Culvert – Replacement

Mountain Loop Highway crosses Goodman Creek about 6 miles southeast of Darrington. The large metal culvert pipe was damaged in early 2020 by heavy storm flows. The road is currently restricted to one lane. FHWA funding has been received to replace the culvert with a bridge and restore fish passage along Goodman Creek. Construction is expected to begin in 2026 pending environmental approvals.

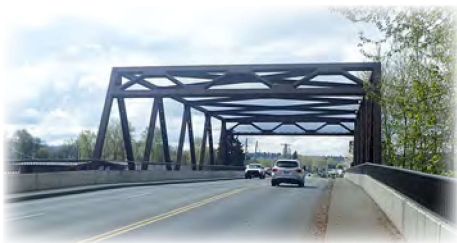
Snohomish River Bridge I – Scour Mitigation

Bridge I carries Airport Way/Avenue D over the Snohomish River in Snohomish. The 360-foot-long three span bridge was built in 1983 with drilled shafts in the river. Snohomish River Bridge I is on our priority “Flood Watch” list and “Seismic Lifeline” bridge route list. The proposed project will improve scour and seismic resiliency. Federal bridge funds are available, and construction is planned for 2025.

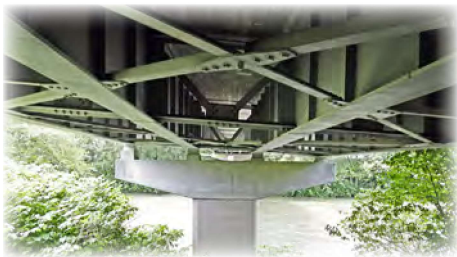
Larson Bridge I01 – Seismic Retrofit

This 304-foot-long three span bridge with seismically deficient elements was built in 1962 prior to current seismic design standards. The bridge carries Larson Road over the South Slough of the Stillaguamish River in Silvana. Federal seismic retrofit funds became available in 2023 and construction is planned in 2028.

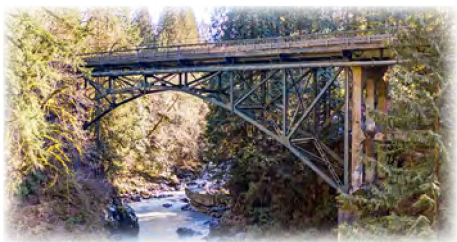
Granite Falls Bridge I02 – Replacement

The steel arch truss bridge, built in 1934, is located north of Granite Falls. It carries the Mountain Loop Highway above the South Fork of the Stillaguamish River. This narrow bridge will have a wider and more resilient replacement. This project received a USDOT RAISE grant in November 2021. Staff is working to complete engineering and environmental permitting. Construction is targeted to begin in 2027, pending funding approvals.

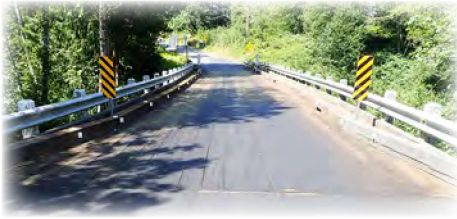
Jordan Creek Bridge 214 – Replacement

This 107-foot long trestle style multi-span bridge was last rebuilt in 1981 and carries Jordan Road over Jordan Creek between Granite Falls and Arlington. Federal bridge replacement funds for the project were received in 2020 and construction is planned for 2025.

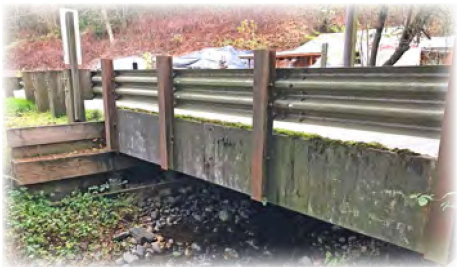
Richardson Creek Bridge 300 – Replacement

This 18-foot-long short span bridge was built in 1961 and is located on Woods Creek Road north of Monroe. Design for the replacement project has been funded and was started in 2018. County staff hosted a public meeting in October 2019 to discuss the proposed project. Construction is planned for 2026 pending permit approvals and construction funding.

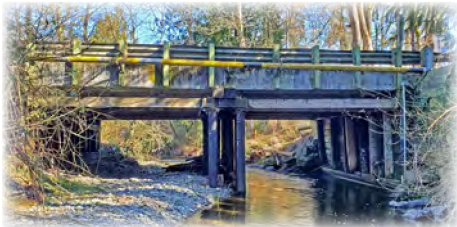
Swamp Creek Bridge 503 – Replacement

This 41-foot long two span bridge was built in 1960 and carries Locust Way over Swamp Creek between Bothell and Brier. Federal bridge replacement funds for the replacement project were received in 2020 and construction is planned for 2025.

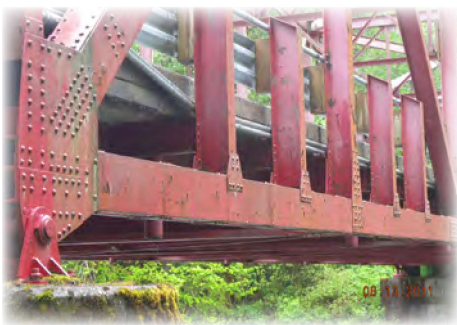
Red Bridge 537 – Preventative Maintenance

This 209-foot-long three span bridge features a 161-foot-long steel through truss. The bridge was built in 1954 and carries traffic on Mountain Loop Highway over the South Fork of the Stillaguamish River, providing the only vehicle access east of Granite Falls to the Mount Baker-Snoqualmie National Forest. Federal bridge funds for repairs and steel structure painting were received in 2021 and construction is planned for 2025.

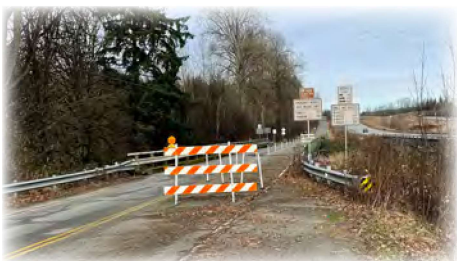
Pilchuck Creek Bridge 626 – Replacement

Bridge 626 located northeast of Arlington carries Old 99 Highway over Pilchuck Creek and was built in 1933. It is posted for restricted loads and has been reduced to one lane. The existing structure is three spans with two in-span hinges and both piers within the ordinary high water. The county proposes to replace the existing bridge with a 180-foot-long single span structure that will clear the creek and provide two travel lanes and a protected walkway. Federal bridge replacement funds are available, and construction is planned for 2027.

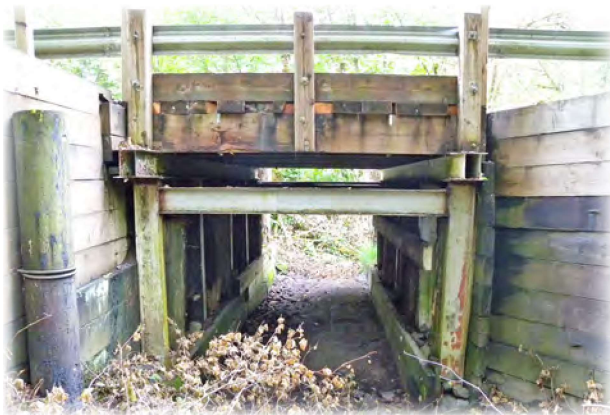
Everett Creek Bridge 565 located 3.5 miles northeast of Darrington on Crawford Loop Road was built in 1985. It is a short span with an overall length of 15 feet (NBIS length of 12 feet).

Bridges with a length of 20' or less are classified as short span bridges and are not eligible for federal replacement or rehabilitation grant funding. Of the county's 33 short span bridges, the following three are planned for replacement using County Road Fund dollars. Two of the bridges are functionally obsolete (FO) and one is a fish passage (FP) restriction.

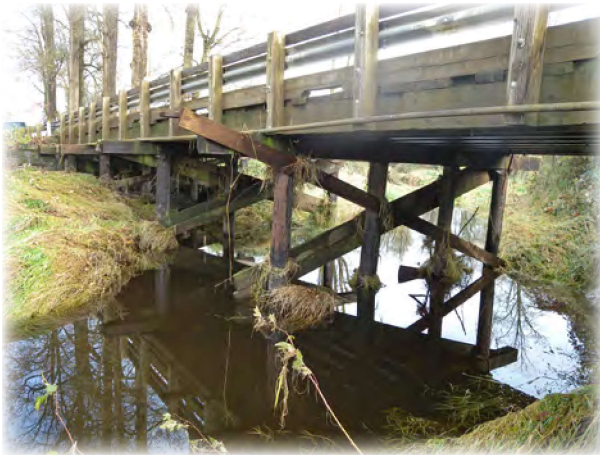
Riley Slough Bridge 52 is a four span bridge built in 1970. The bridge has a timber deck, superstructure, and substructure. Extensive repairs to the bridge necessitated a full road closure, and the condition of the substructure warrants a Structurally Deficient status. The county will pursue replacement funding.

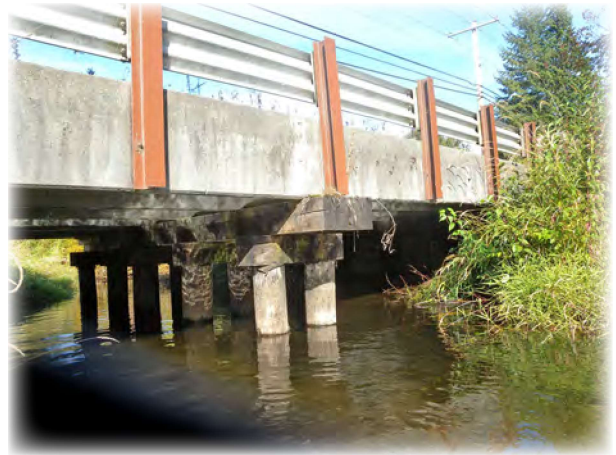
Gregory Road Bridge 272 is a two span bridge built in 1961. The bridge has a concrete tub superstructure and timber substructure. The condition of the substructure needs extensive maintenance and repairs and warrants a Structurally Deficient status. The county will pursue replacement funding.

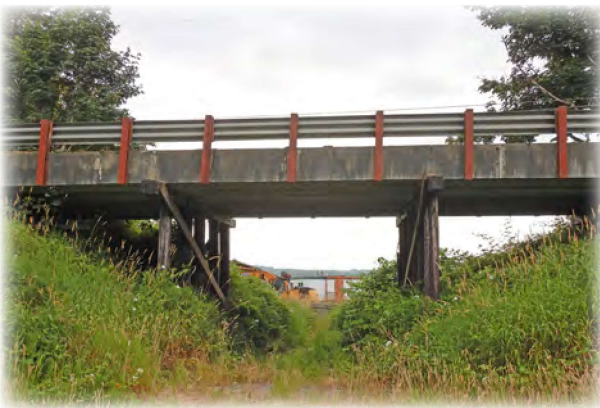
Cattle Pass Bridge 183 is a three span bridge on Lowell-Larimer Road, which was last rebuilt in 1966. The deteriorating wood substructure necessitated a load posting in 2023. The bridge is on an important agricultural and commuter route, as well as a seismic lifeline route. The county will pursue replacement funding.

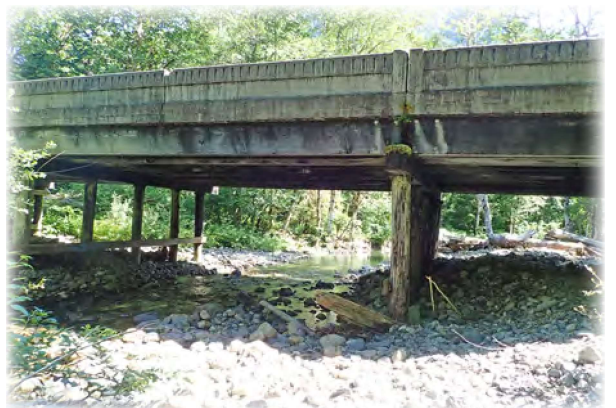
Deer Creek Bridge 670 built in 1949 on Mountain Loop Highway has original 8 x 24-inch treated timber sawn girders, and original concrete deck and railing. The bridge was retrofitted in 2023.

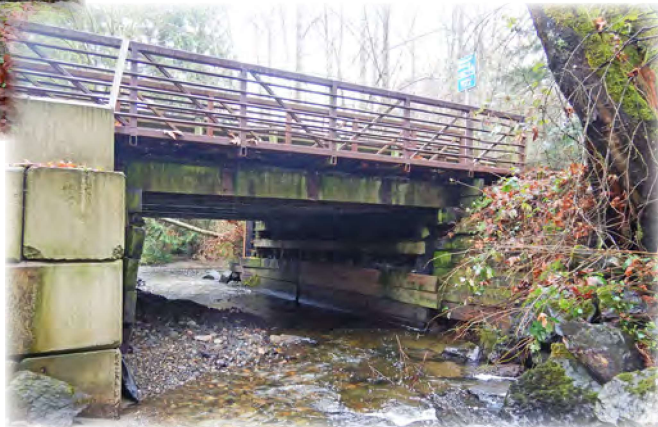
The recycled pre-fabricated pedestrian bridge is a major improvement for pedestrians using Scriber Creek Bridge 366.

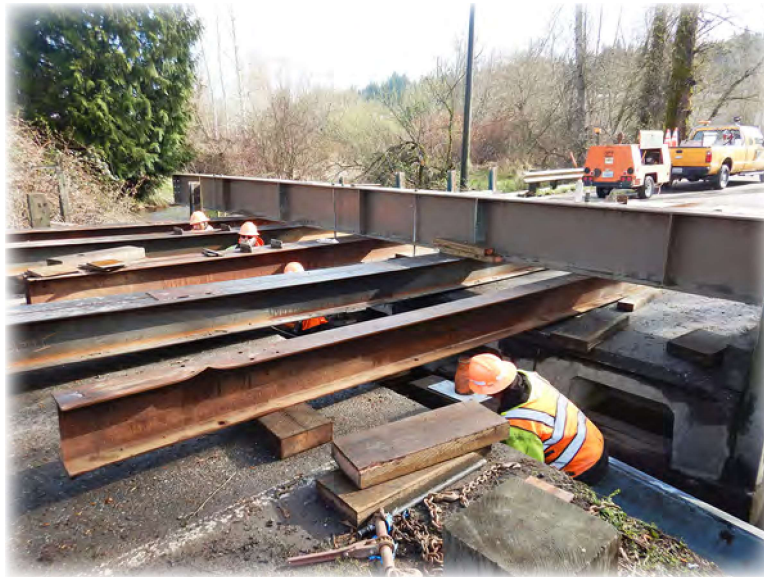
Snohomish County Bridge Crew jacking up Bear Creek Bridge 625 for replacement of the rotten timber caps.

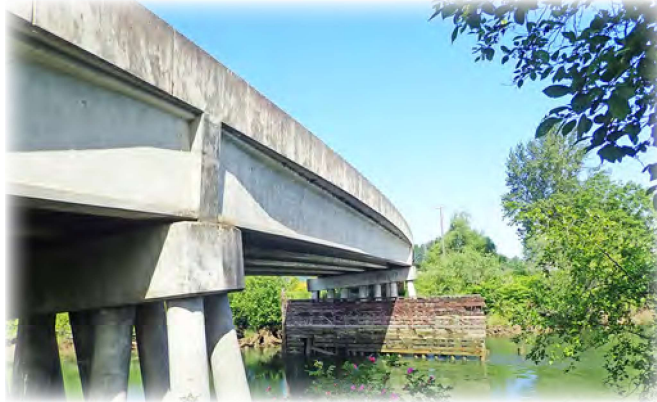
Ebey Slough Bridge 3 built in 1976 on Home Acres Road is one of the county's Lifeline Route bridges. It is located in Everett in the Snohomish River valley 1.3 miles east of Lowell and the Snohomish River.

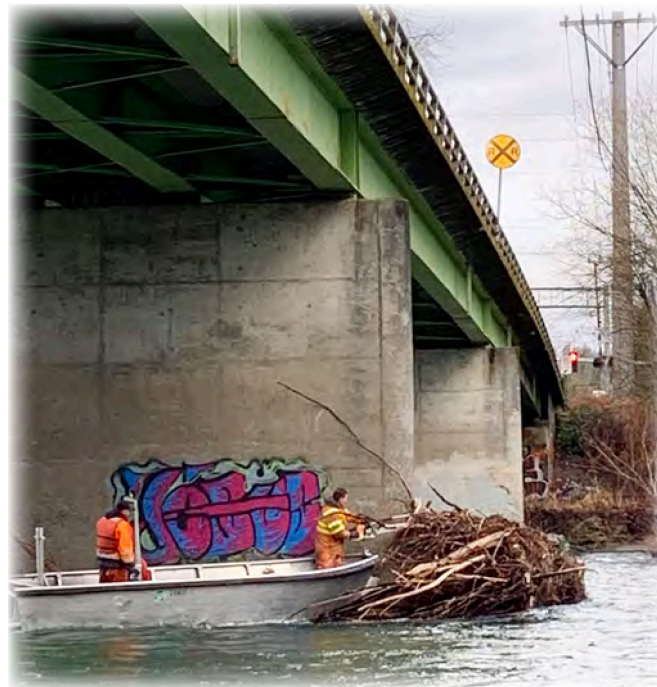
Sultan Bridge 94 on Mann Road and over the Skykomish River in Sultan was built in 1961. WSDOT maintenance crew members were hired by the county to break up some of the trapped wood debris at Pier 2.

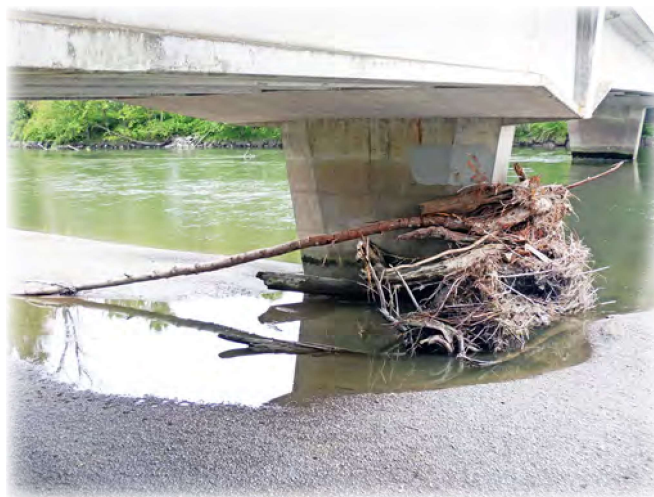
Jim Donner Bridge 4 with a log jam at one of the internal piers due to flood waters. The bridge was built over the Stillaguamish River on Marine Drive in 1985.
