2021 Annual Bridge Report

Prepared by: Snohomish County Public Works
Engineering Services Bridge Group

2021 Bridge Report

This bridge report is prepared by Snohomish County Public Works Engineering Services Bridge Group each year to fulfill requirements of the Washington Administrative Code (WAC) 136-20-060. This WAC requires the County Engineer’s report of bridge inspections as follows:

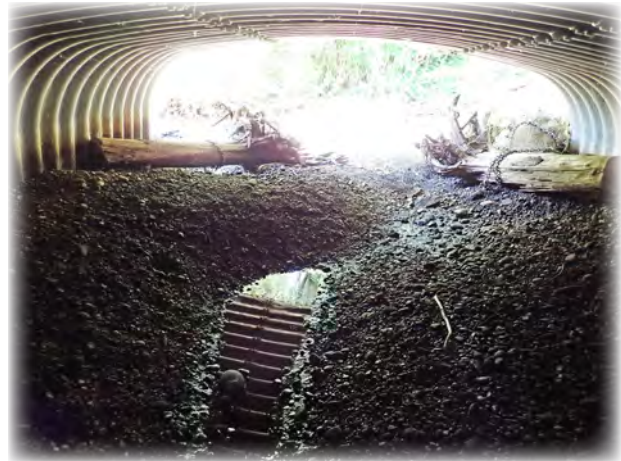
Bridge 14 is a corrugated aluminum culvert carrying Swamp Creek at the intersection of Gibson Road and Admiralty Way. A scour mitigation work order was completed in the fall of 2017.

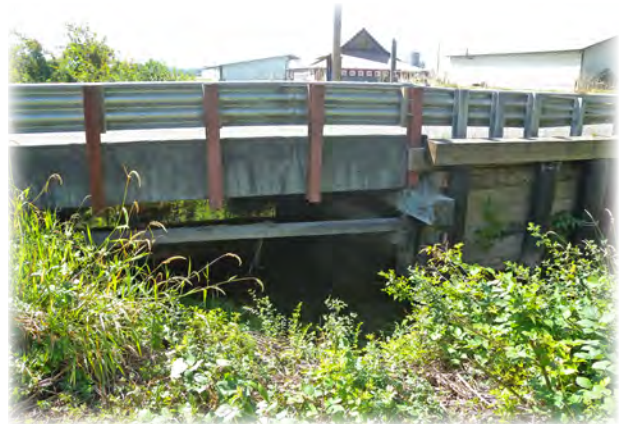
Portage Creek Bridge 311 on 43rd Ave NE in Arlington is a short span built in 1972. It's an example of one of our bridges that is a combination of wood and concrete construction.

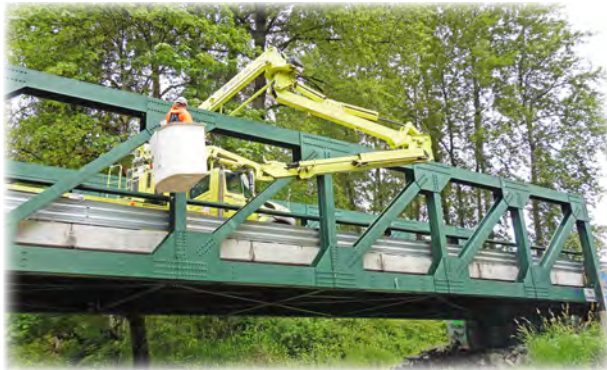
Pilchuck River Bridge 581, built in 2016 near Lochsloy, is one of nine steel trusses in the county. The bridge underwent a biennial special inspection in 2021 utilizing a WSDOT UBIT truck.

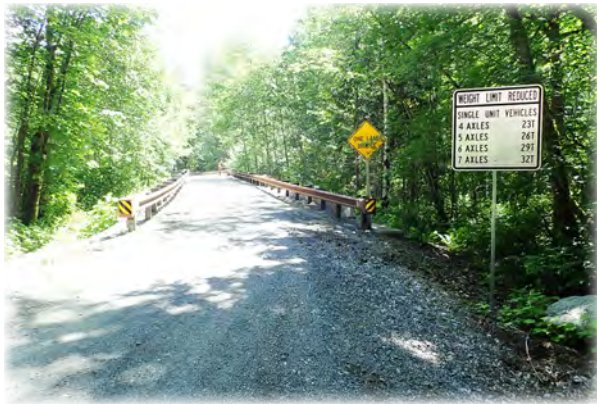
South Fork Sauk River Bridge 540 on Reece’s Hideout Road has a both a width and weight restriction.

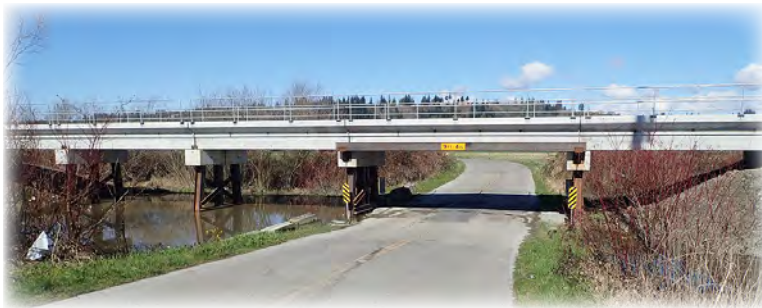
Olsen Road Railroad Underpass is height restricted. In 2019 BNSF replaced an all timber trestle with a steel and concrete bridge.

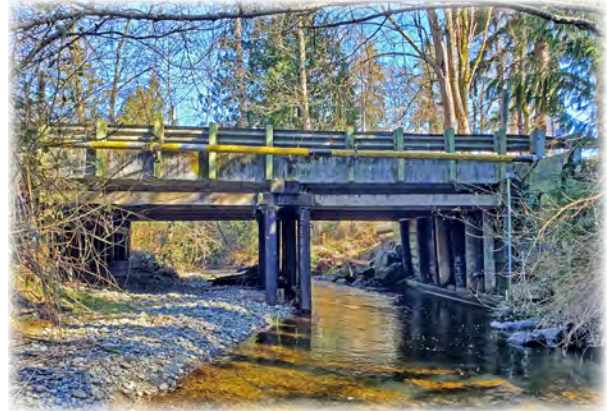
Swamp Creek Bridge 503.

This 41-foot long two span bridge was built in 1960 and carries Locust Way over Swamp Creek between Bothell and Brier. Federal bridge replacement funds for the replacement project were received in 2020 and construction is planned for 2024.

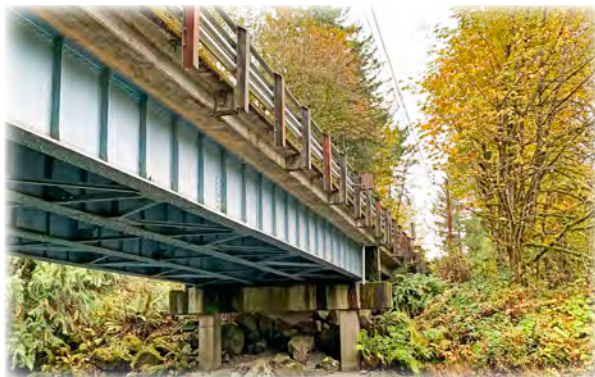
Madden Bridge 58.

This 138-foot long three span bridge was built in 1956 and carries Menzel Lake Road over Pilchuck River between Granite Falls and Lake Stevens. Federal bridge funds for the rehabilitation project were received in 2020 and construction is planned for 2022. The proposed work includes a concrete overlay for the bridge deck, and improvements to the bridge rail and adjacent pavement.

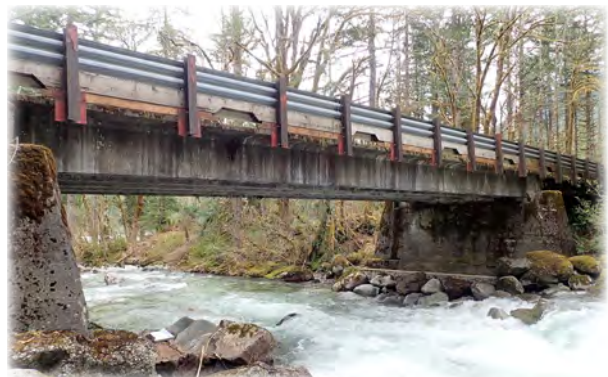
Trout Creek Bridge 494.

This 120-foot long three span bridge was built in 1946 and is located on Index-Galena Road over Trout Creek northeast of Index. The proposal is to replace this bridge with a single span structure. This project currently has Rural Arterial Program (RAP) funds from the state, and we will continue to seek additional funding.

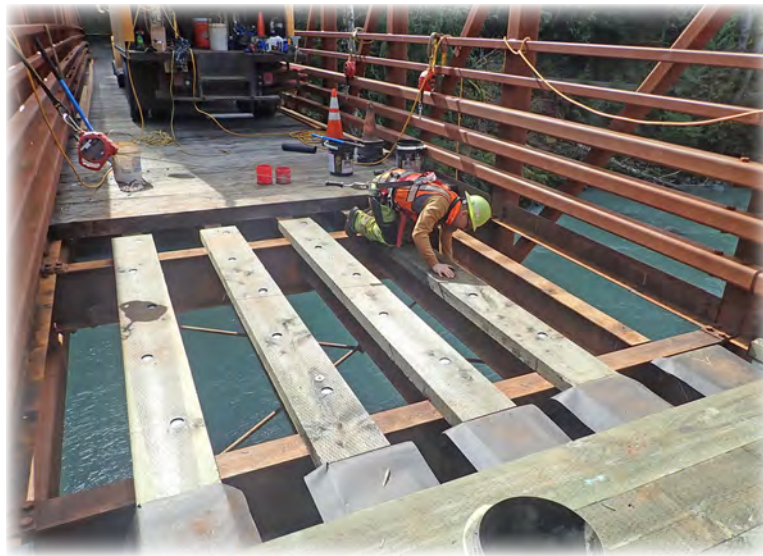
South Fork Stillaguamish Bridge 660 retrofit. The crew is attaching pressure-treated nailer planks to steel stringers for decking system replacement.

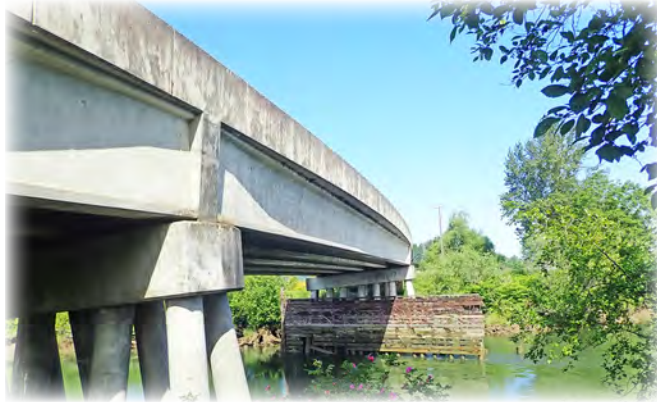
Ebey Slough Bridge 3 built in 1976 on Home Acres Road is one of the county's Lifeline Route bridges. It is located in Everett in the Snohomish River valley 1.3 miles east of Lowell and the Snohomish River.

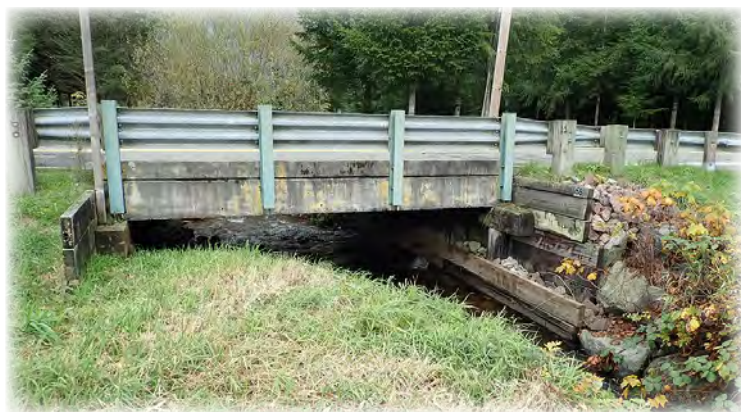
Barr Creek Bridge 158 is a short span bridge on Ben Howard Road and built in 1956 in the Monroe area. It is functionally obsolete due to its narrow deck width and high ADT, which classifies it as a future replacement candidate.

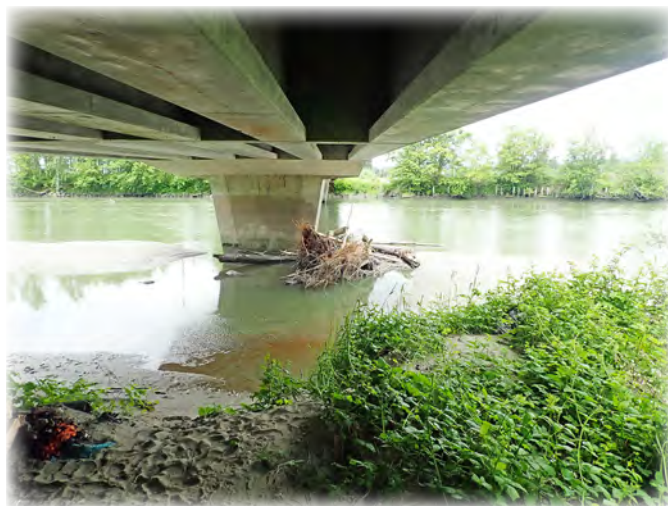
Jim Donner Bridge 4 with a log jam at one of the internal piers due to flood waters. Bridge was built over the Stillaguamish River on Marine Drive in 1985.
