MOTION ADOPTING THE 2021 BRIDGE REPORT

2021 Annual Bridge Report

Prepared by: Snohomish County Public Works
Engineering Services Bridge Group

Submitted: May 2022

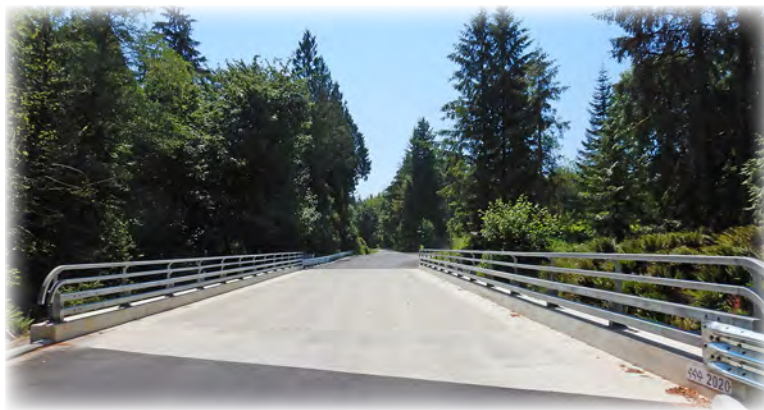
Kackman Creek Bridge No. 676 is a new 119-foot long single-span prestressed concrete girder bridge that opened in 2021. The bridge was built by the Stillaguamish Tribe in coordination with Snohomish County. The bridge carries 55th Avenue NE across Kackman Creek and replaces the old culvert, which was a fish barrier.

- Construction was completed for Kackman Creek Bridge 676 by the Stillaguamish Tribe. The new 119 foot long bridge replaced a culvert to aid fish passage on 55th Ave NE, which accesses a Tribal Community Center.

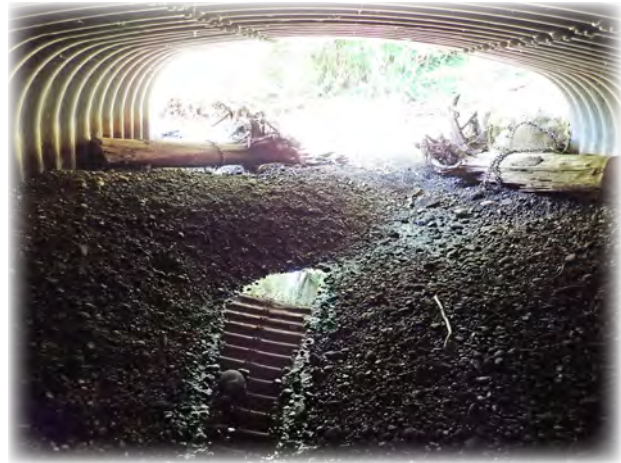
Bridge 14 is a corrugated aluminum culvert carrying Swamp Creek at the intersection of Gibson Road and Admiralty Way. A scour mitigation work order was completed in the fall of 2017.

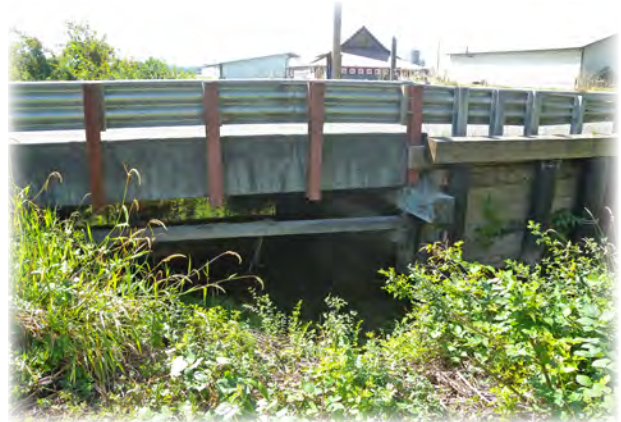
Portage Creek Bridge 311 on 43rd Ave NE in Arlington is a short span built in 1972. It's an example of one of our bridges that is a combination of wood and concrete construction.

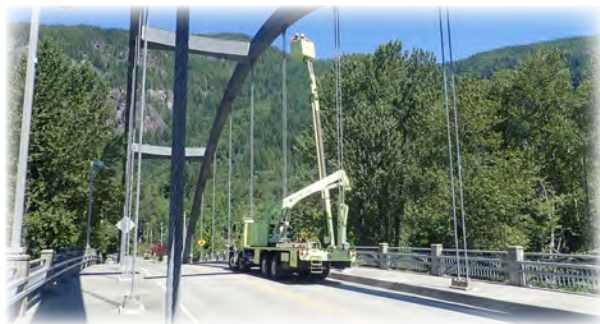
Wes Smith Bridge 122 over the N.F. Skykomish River in Index. County and WSDOT bridge inspectors inspecting the bridge’s steel arch and cables via a WSDOT UBIT.

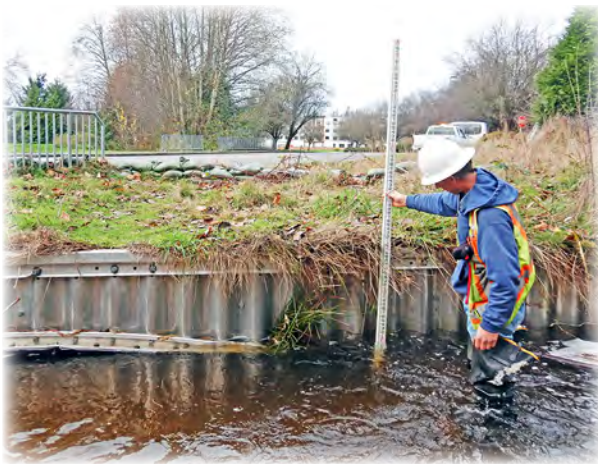
The inspector pictured above is measuring scour on Prairie Creek Culvert for the city of Arlington.

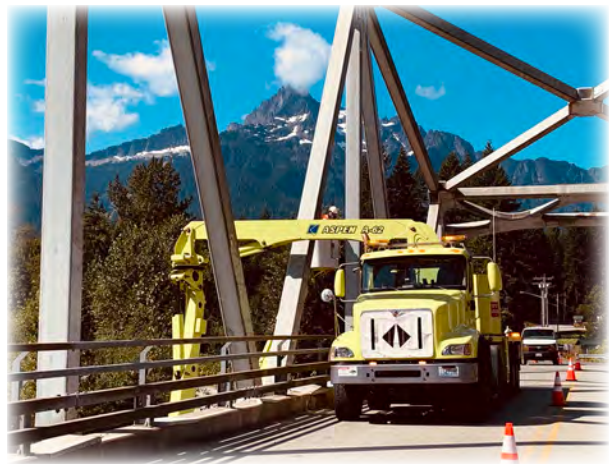
Sauk River Bridge 414 on Sauk Prairie Road. County and WSDOT bridge inspectors inspecting the bridge's steel truss via a WSDOT UBIT.

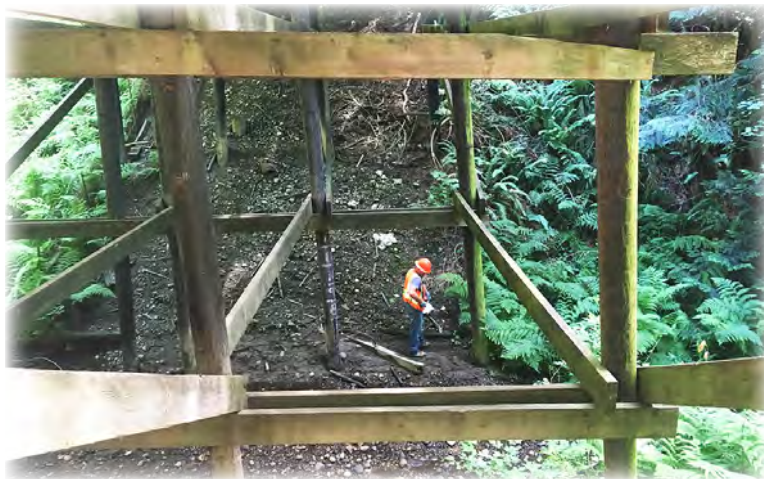
Fisher Creek Bridge 433 on English Grade Road. County bridge inspector examining timber piles and braces.

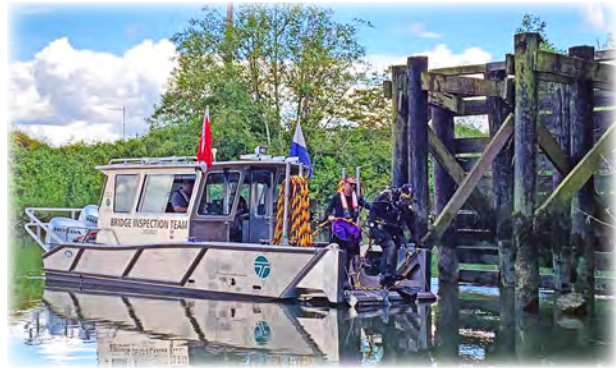
Ebey Slough Bridge 3 is one of five bridges which requires underwater inspections. Snohomish County works with the WSDOT underwater inspection diving team. Divers are checking scour depth.

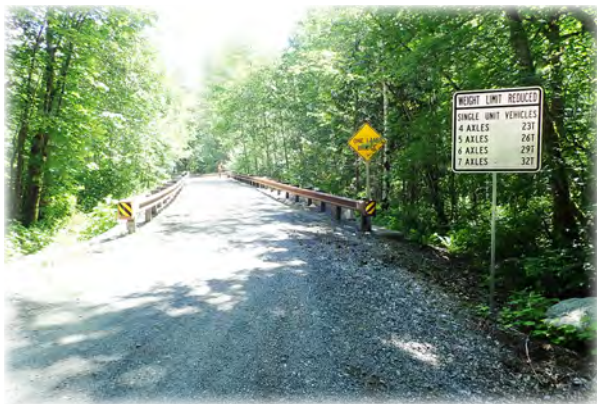
South Fork Sauk River Bridge 540 on Reece’s Hideout Road has a both a width and weight restriction.

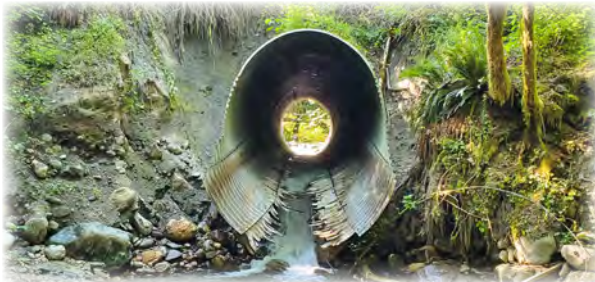
Mountain Loop Highway crosses Goodman Creek about 6 miles southeast of Darrington. The large metal culvert pipe was damaged in early 2020 by heavy storm flows. The road is currently restricted to one lane. Snohomish County Public Works has secured FHWA funding to replace the culvert with a bridge and restore fish passage along Goodman Creek. Construction is expected to begin in 2024 pending environmental approvals.

Metal culvert pipe damaged in early 2020.

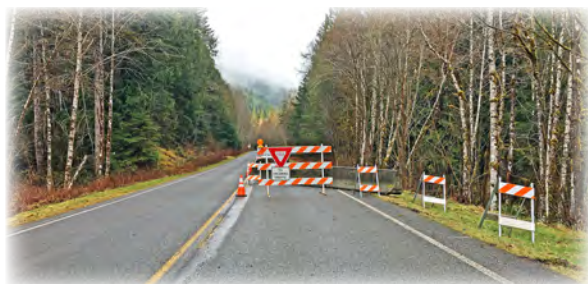
Mountain Loop Highway is currently restricted to one lane.

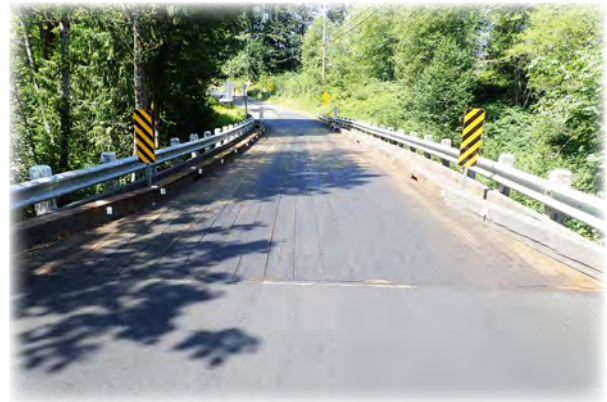
Jordan Creek Bridge 214.

This 107-foot long trestle style multi-span bridge was last re-built in 1981 and carries Jordan Road over Jordan Creek between Granite Falls and Arlington. Federal bridge replacement funds for the project were received in 2020 and construction is planned for 2024.

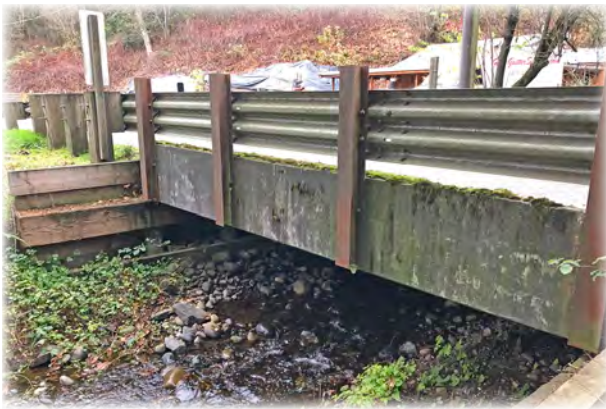
Richardson Creek Bridge 300.

This 18-foot long short span bridge was built in 1961 and is located on Woods Creek Road north of Monroe. Design for the replacement project has been funded and was started in 2018. County staff hosted a public meeting in October 2019 to discuss the proposed project. Construction is planned for 2026 pending permit approvals and construction funding

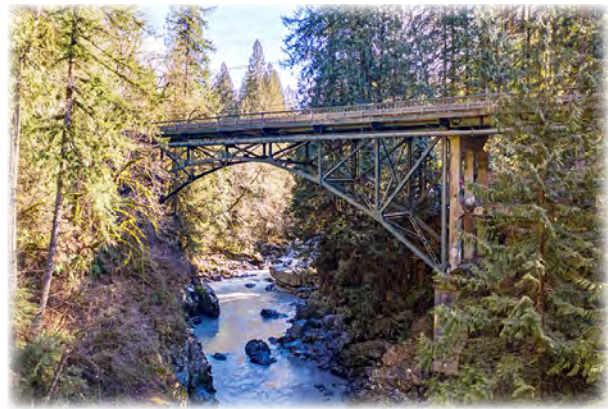
Granite Falls Bridge 102.

The steel arch truss bridge, built in 1934, is located north of Granite Falls. It carries the Mountain Loop Highway above the South Fork of the Stillaguamish River. This narrow and fracture critical bridge will have a wider and more resilient replacement. This project received a USDOT RAISE grant in November 2021. Staff is working to complete engineering and environmental permitting with construction targeted to begin in 2025.

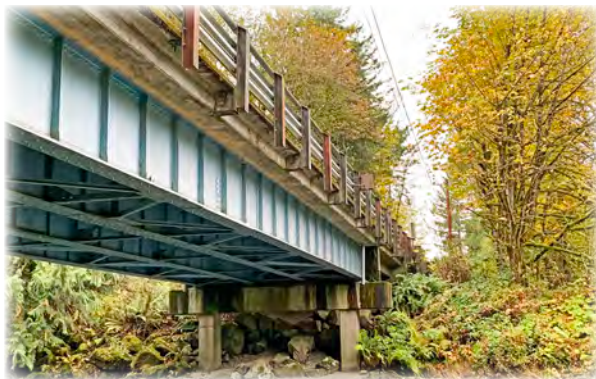
Madden Bridge 58.

This 138-foot long three span bridge was built in 1956 and carries Menzel Lake Road over Pilchuck River between Granite Falls and Lake Stevens. Federal bridge funds for the rehabilitation project were received in 2020 and construction is planned for 2022. The proposed work includes a concrete overlay for the bridge deck, and improvements to the bridge rail and adjacent pavement.

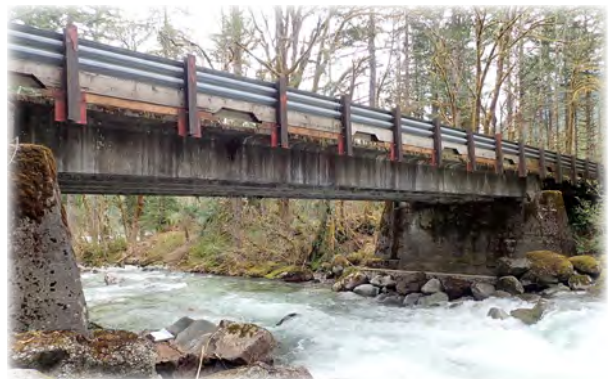
Trout Creek Bridge 494.

This 120-foot long three span bridge was built in 1946 and is located on Index-Galena Road over Trout Creek northeast of Index. The proposal is to replace this bridge with a single span structure. This project currently has Rural Arterial Program (RAP) funds from the state, and we will continue to seek additional funding.

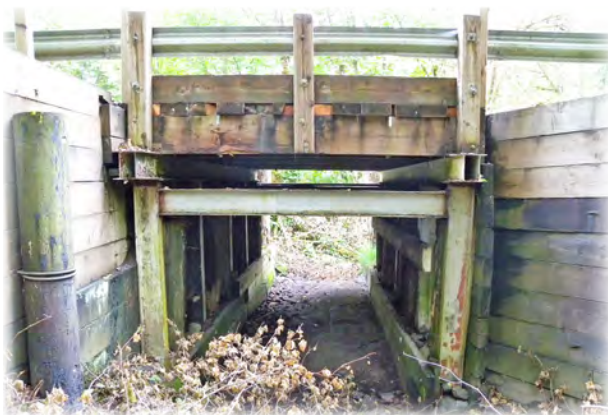
Everett Creek Bridge 565 located 3.5 miles northeast of Darrington on Crawford Loop Road was built in 1985. It is a short span with an overall length of 15 feet (NBIS length of 12 feet) and has a fish passage restriction. The bridge is planned to be replaced with a longer structure.

* As a condition of the last deck and stringers replacement, Washington Department of Fish & Wildlife required a complete replacement of Bridge 565.

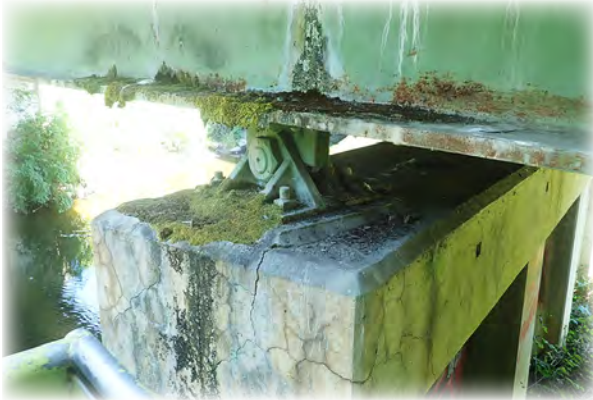
Pilchuck Creek Bridge 626 on Old 99 North and built in 1933. Rusting steel girders, exposed aggregate on concrete deck and significant cracking of many other concrete elements classifies this bridge as a future rehabilitation candidate.

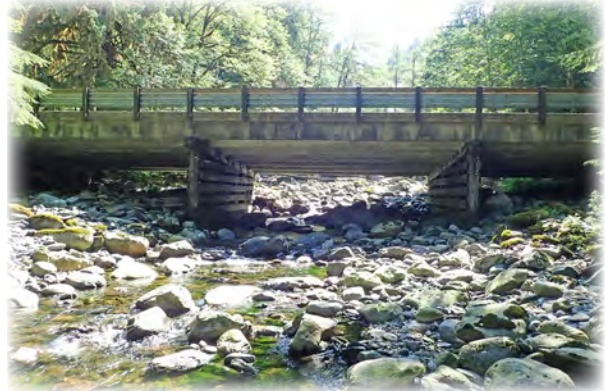
Black Creek Bridge 547 built in 1952 on Mountain Loop Highway. Exposure of shallow concrete spread footings classifies this scour critical bridge as a future rehabilitation candidate.

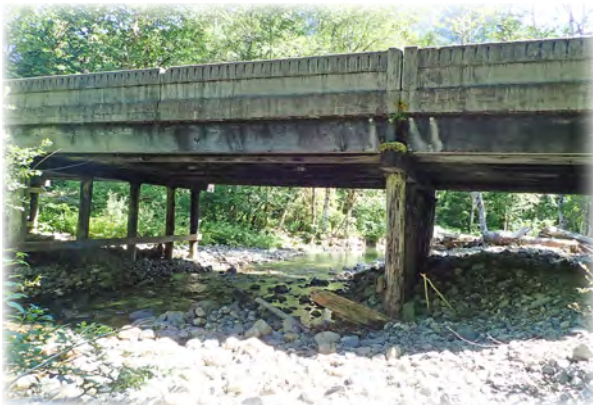
Deer Creek Bridge 670 built in 1949 on Mountain Loop Highway. Currently has 13 lines of 6 spans of original 8 x 24-inch treated timber sawn girders, and original concrete deck and railing.

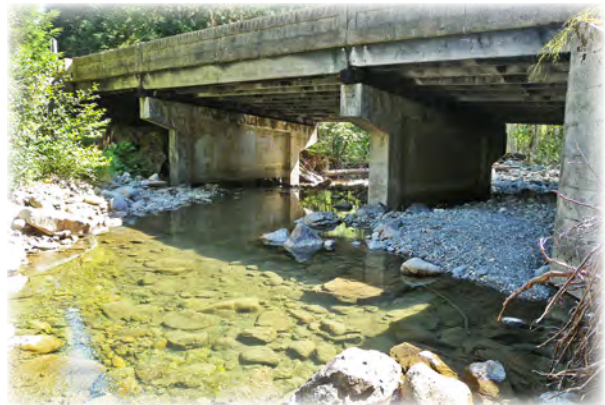
Coal Creek Bridge 556 built in 1949 on Mountain Loop Highway. It has 13 lines of 3 spans of original 6 x 20-inch (spans 1 and 3) and 8 x 24-inch (span 2) treated timber sawn girders, and original cast-in-place concrete piers, deck and railing.

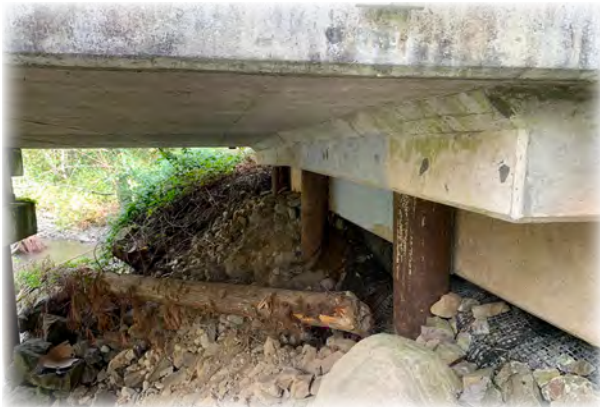
Wallace River Bridge 536 built in 1970 in Gold Bar. The rock abutment wall wrapped in geogrid at the south end of the bridge was punctured by a log during a highwater event causing the wraps to collapse and roadway pavement to settle.

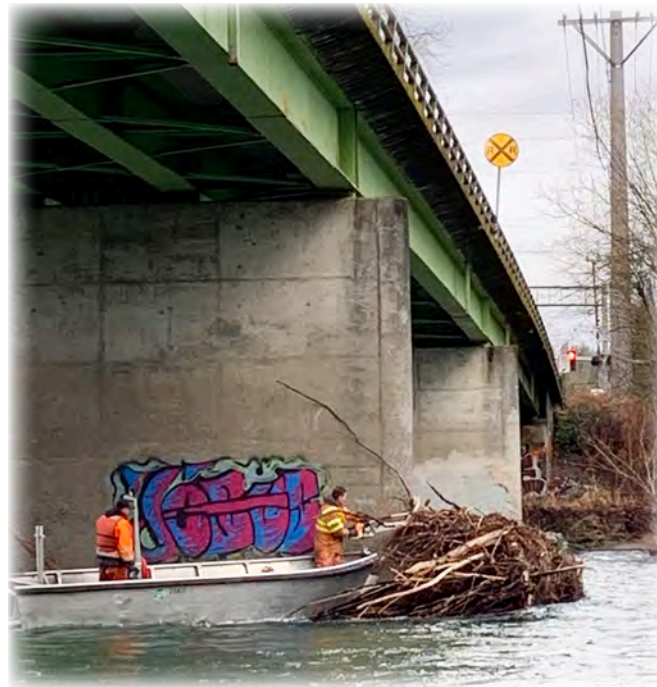
Sultan Bridge 94 on Mann Road and over the Skykomish River in Sultan was built in 1961. WSDOT maintenance crew members were hired by the county to break up some of the trapped wood debris at Pier 2.

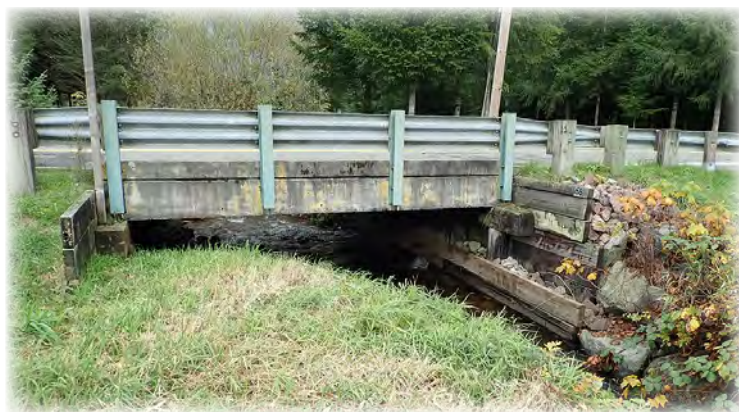
Barr Creek Bridge 158 is a short span bridge on Ben Howard Road and built in 1956 in the Monroe area. It is functionally obsolete due to its narrow deck width and high ADT, which classifies it as a future replacement candidate.

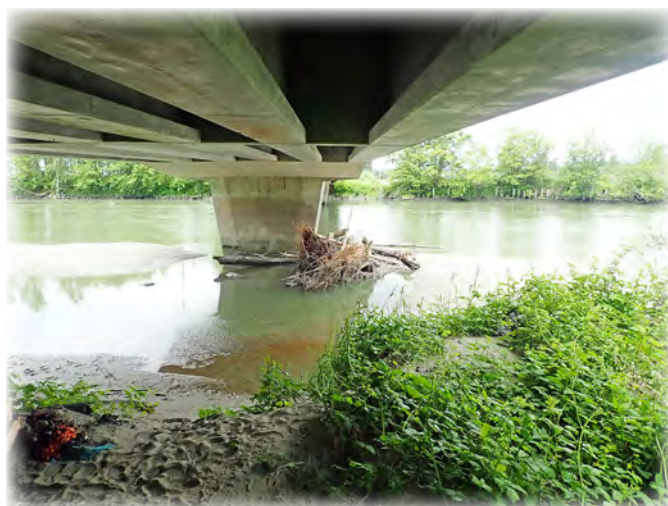
Jim Donner Bridge 4 with a log jam at one of the internal piers due to flood waters. Bridge was built over the Stillaguamish River on Marine Drive in 1985.
