2024 Annual Bridge Report

Prepared by: Snohomish County Public Works
Engineering Services Bridge Group

Submitted: May 2025

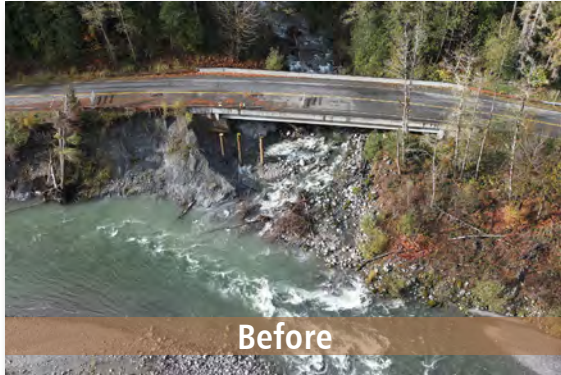
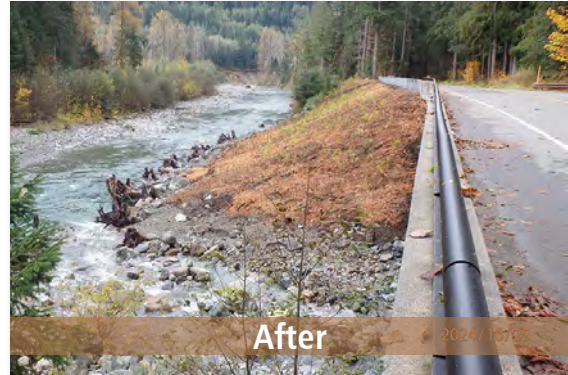
Marten Creek Bridge 562 is located on Mountain Loop Highway. This major embankment repair project was completed to maintain the bridge approach roadway.

Embankment repair with large woody debris at the ordinary high water has been completed and the bridge roadway approach is restored.

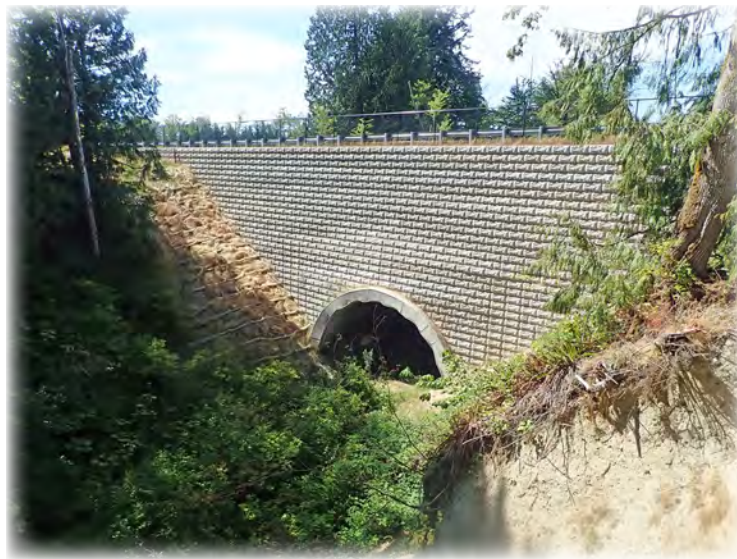
Woods Creek Vista Bridge 682 is a developer-built corrugated steel arch culvert spanning 32 feet over an unnamed creek in a new housing development just northeast of Monroe.

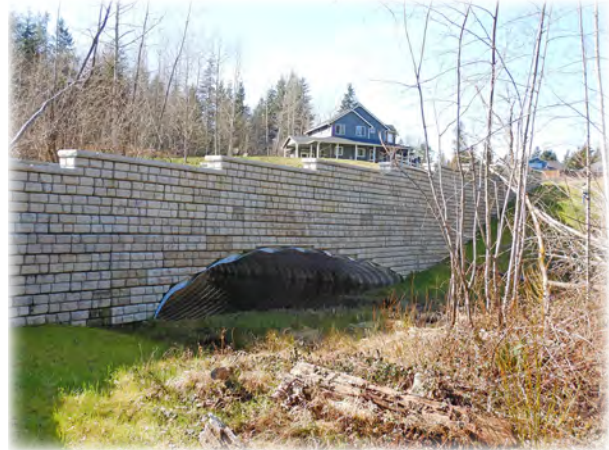
Reiner Bluff Bridge 675 is a developer-built corrugated steel arch culvert spanning 54 feet over a wetland on 120th St. SE just northwest of Sultan.

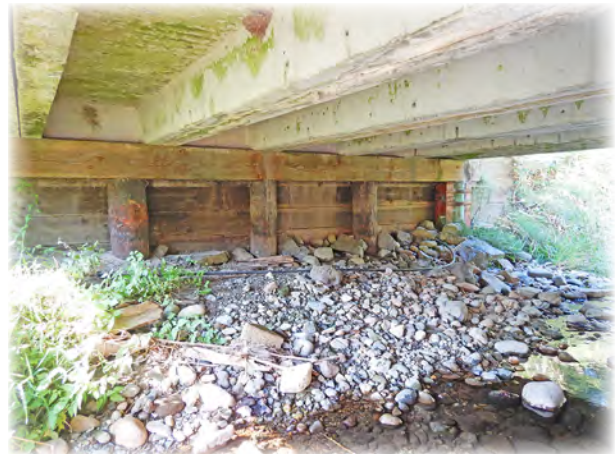
Barr Creek Bridge 158 on Ben Howard Rd located in Sultan is a short span built in 1956. It's an example of one of our bridges that is a combination of wood and concrete construction. The major rehabilitation project for Barr Creek Bridge 158 is currently in the design phase.

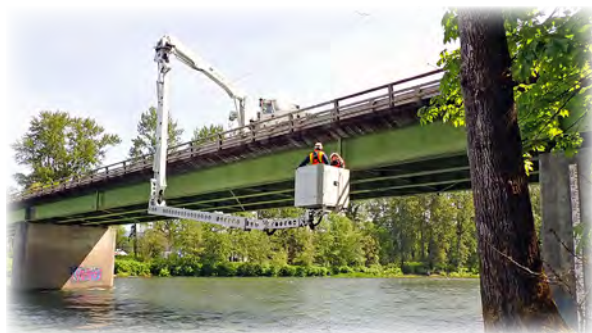
County and WSDOT inspectors in a UBIT looking at the condition of the Sultan Bridge 94 painted girders.

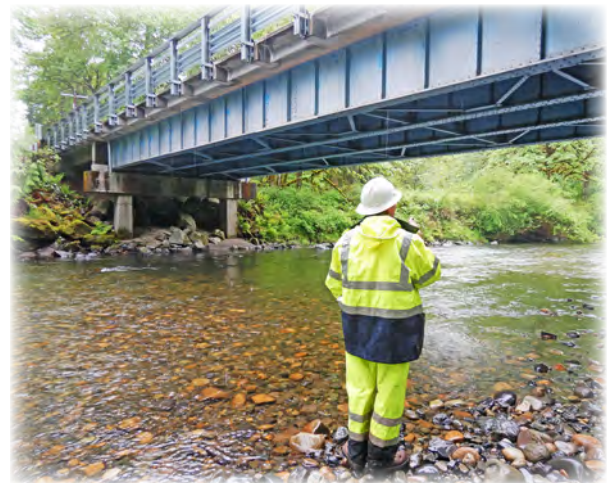
County bridge inspector evaluating the steel girders and rail system at Madden Bridge 58.

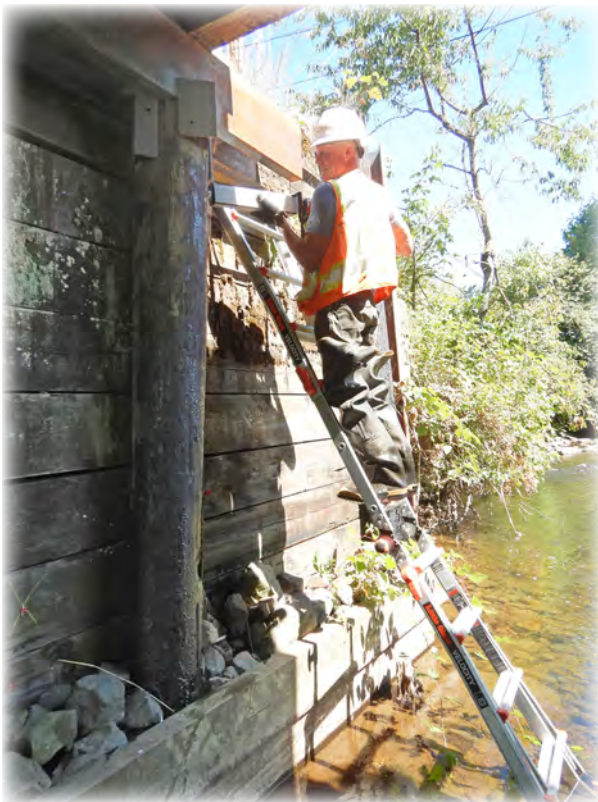
County bridge inspector drilling a timber pile at Bridge 443 to evaluate the condition and detect any decay.

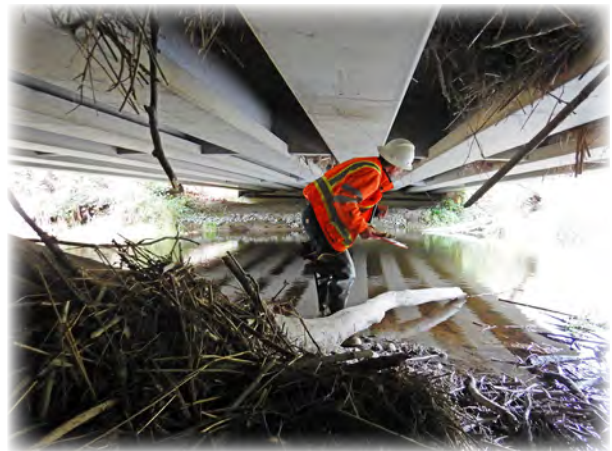
County bridge inspector under Skykomish River Slough bridge #150. High water events can cause vegetation to accumulate between the girders.

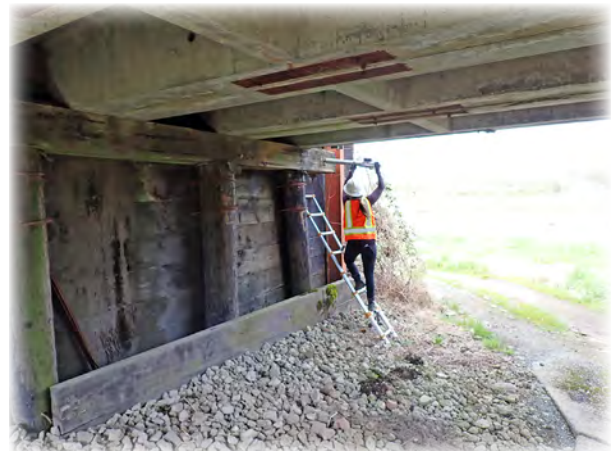
County bridge inspector drilling the timber cap at Cattle Pass bridge #190 during a routine inspection.

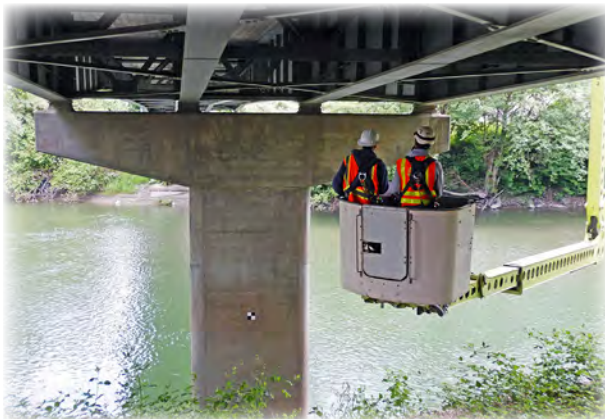
County and WSDOT Inspectors in a UBIT conducting an inspection of the steel girders at Larson Bridge 101.

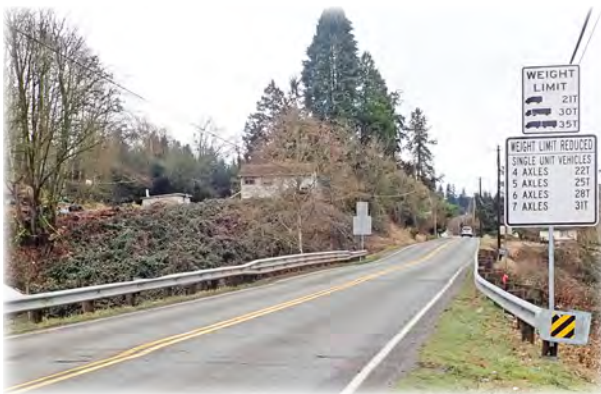
Cattle Pass Bridge 183 on Lowell-Larimer Road has weight limits posted.

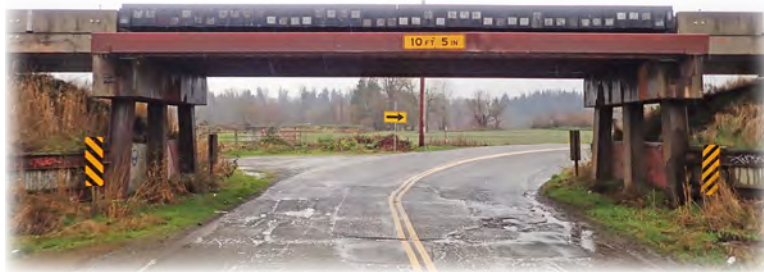
Norman Road Underpass is height restricted. Snohomish County conducts a Safety Inspection of this BNSF steel and concrete bridge constructed in 2013 near Stanwood.

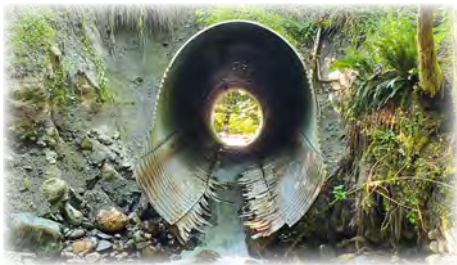
Goodman Creek Culvert – Replacement

Mountain Loop Highway crosses Goodman Creek about 6 miles southeast of Darrington. The large metal culvert pipe was damaged in early 2020 by heavy storm flows. The road is currently restricted to one lane. FHWA funding has been received to replace the culvert with a bridge and restore fish passage along Goodman Creek. Construction is expected to begin in 2026 pending environmental approvals.

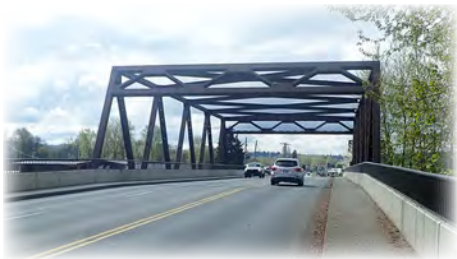
Snohomish River Bridge I – Scour Mitigation

Bridge I carries Airport Way/Avenue D over the Snohomish River in Snohomish. The 360-foot-long three span bridge was built in 1983 with drilled shafts in the river. Snohomish River Bridge I is on our priority "Flood Watch" list and "Seismic Lifeline" bridge route list. The proposed project will improve scour and seismic resiliency. Federal bridge funds are available, and construction is planned for 2027, pending permit approvals.

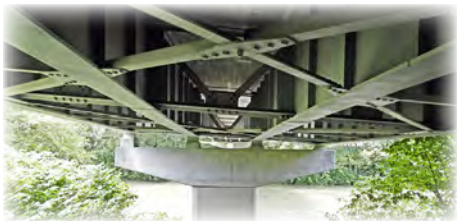
Larson Bridge 101 – Seismic Retrofit

This 304-foot-long three span bridge with seismically deficient elements was built in 1962 prior to current seismic design standards. The bridge carries Larson Road over the South Slough of the Stillaguamish River in Silvana. Federal seismic retrofit funds became available in 2024 and construction is planned in 2028.

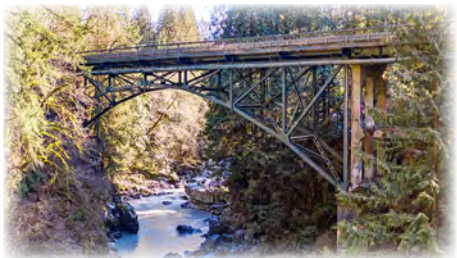
Granite Falls Bridge 102 – Replacement

The steel arch truss bridge, built in 1934, is located north of Granite Falls. It carries the Mountain Loop Highway above the South Fork of the Stillaguamish River. This narrow bridge will have a wider and more resilient replacement. This project received a USDOT RAISE grant in November 2021. Staff is working to complete engineering and environmental permitting. Construction is targeted to begin in 2028, pending permitting and funding approvals.

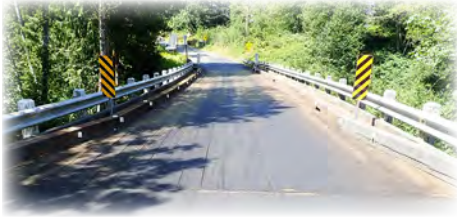
Jordan Creek Bridge 214 – Replacement

This 107-foot long trestle style multi-span bridge was last rebuilt in 1981 and carries Jordan Road over Jordan Creek between Granite Falls and Arlington. Federal bridge replacement funds for the project were received in 2020 and construction is planned for 2025.

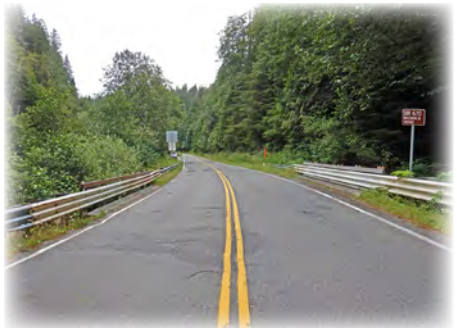
Schweitzer Creek Bridge 576 and Wisconsin Creek Bridge 620 – Rehabilitation

65+ years old Schweitzer Creek Bridge 576 and Wisconsin Creek Bridge 620 are located on Mountain Loop Highway (MLH). MLH serves only access to USFS lands; to homes & cabins, recreational destinations and logging/mining claims between City of Granite and the Town of Darrington. Federal Land Access Program (FLAP) funds are granted in 2021 for grinding off excessive asphalt on the bridge decks and replacing with wearing course. Construction is planned in 2026.

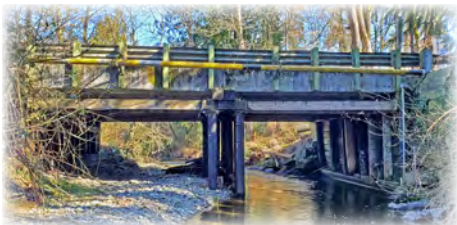
Swamp Creek Bridge 503 – Replacement

This 41-foot long two span bridge was built in 1960 and carries Locust Way over Swamp Creek between Bothell and Brier. Federal bridge replacement funds for the replacement project were received in 2020 and the project has been awarded for construction in 2025.

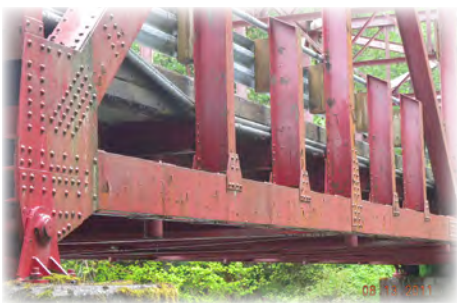
Red Bridge 537 – Preventative Maintenance

This 209-foot-long three span bridge features a 161-foot-long steel through truss. The bridge was built in 1954 and carries traffic on Mountain Loop Highway over the South Fork of the Stillaguamish River, providing the only vehicle access east of Granite Falls to the Mount Baker-Snoqualmie National Forest. Federal bridge funds for repairs and steel structure painting were received in 2021 and the project has been awarded for construction in 2025.

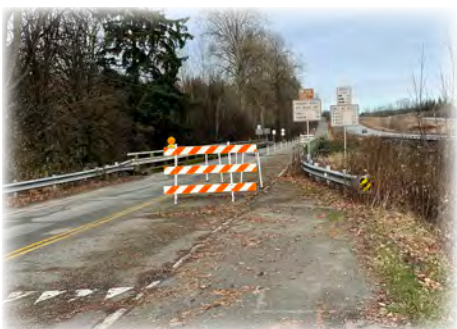
Pilchuck Creek Bridge 626 – Replacement

Bridge 626 located northeast of Arlington carries Old 99 Highway over Pilchuck Creek and was built in 1933. It is posted for restricted loads and has been reduced to one lane. The existing structure is three spans with two in-span hinges and both piers within the ordinary high water. The county proposes to replace the existing bridge with a single span structure that will clear the creek and provide two travel lanes and a protected walkway. Federal bridge replacement funds are available, and construction is planned for 2028.

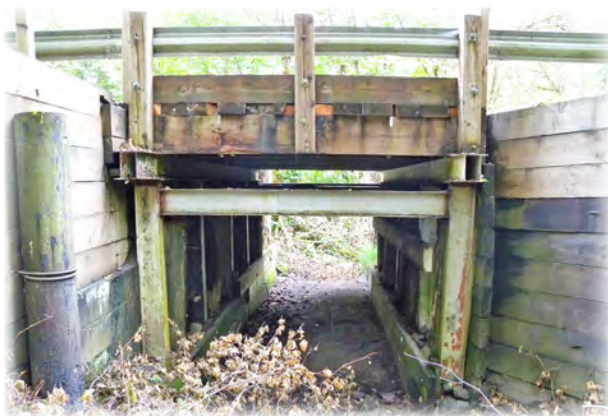
Everett Creek Bridge 565 located 3.5 miles northeast of Darrington on Crawford Loop Road was built in 1985. It is a short span with an overall length of 15 feet (NBIS length of 12 feet).

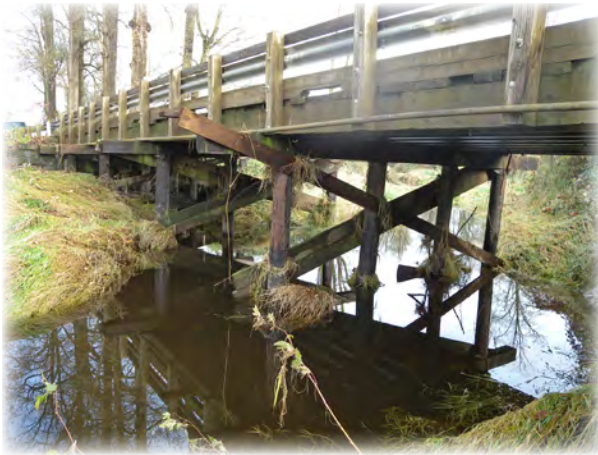
Riley Slough Bridge 52 is a four span bridge built in 1970. The bridge has a timber deck, superstructure, and substructure. Extensive repairs to the bridge necessitated a full road closure, and the condition of the substructure is poor. The county will pursue replacement funding.

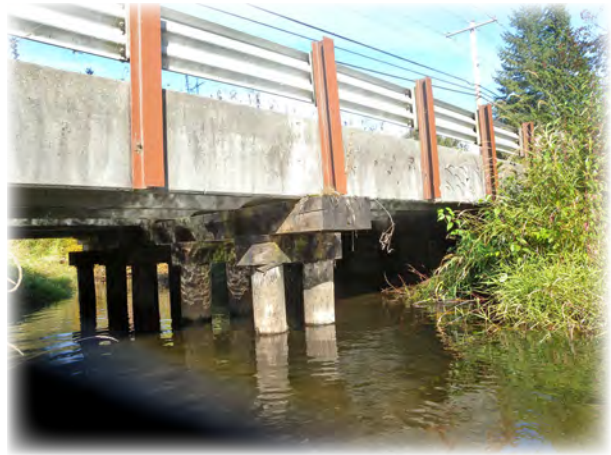
Gregory Road Bridge 272 is a two span bridge built in 1961. The bridge has a concrete tub superstructure and timber substructure. The condition of the substructure requires extensive maintenance, as it is in poor condition. The county will pursue replacement funding.

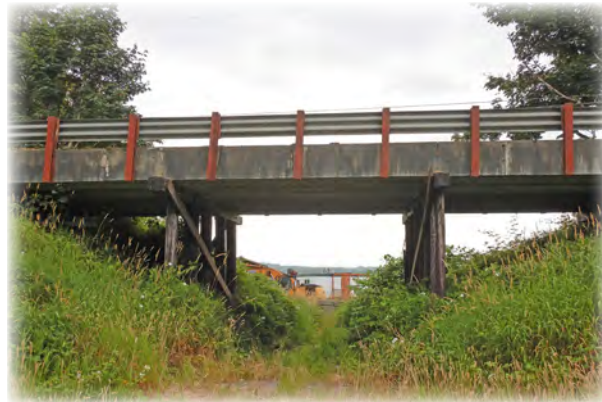
Cattle Pass Bridge 183 is a three span bridge on Lowell-Larimer Road, which was last rebuilt in 1966. The deteriorating wood substructure necessitated a load posting in 2023. The bridge is on an important agricultural and commuter route, as well as a seismic lifeline route. The county will pursue replacement funding.

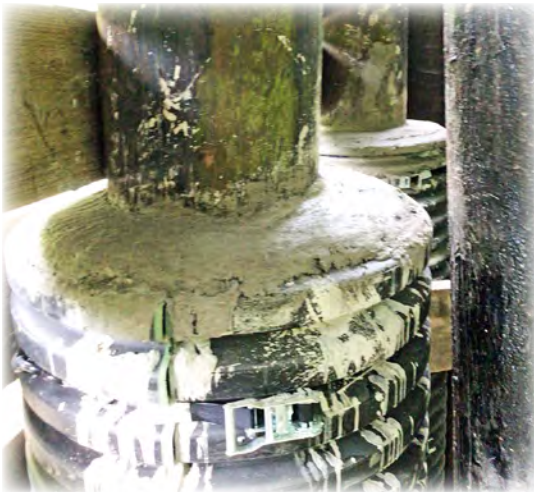
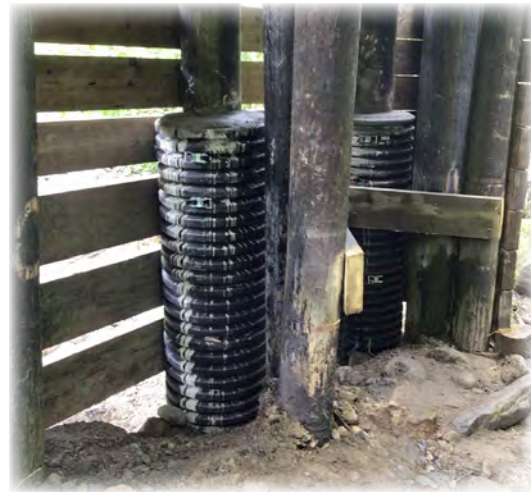
Typical Timber Bridge Decay Types

The Snohomish County Bridge Maintenance Crew is working on Silverton Bridge 56, retrofitting deteriorated piling with concrete jackets.

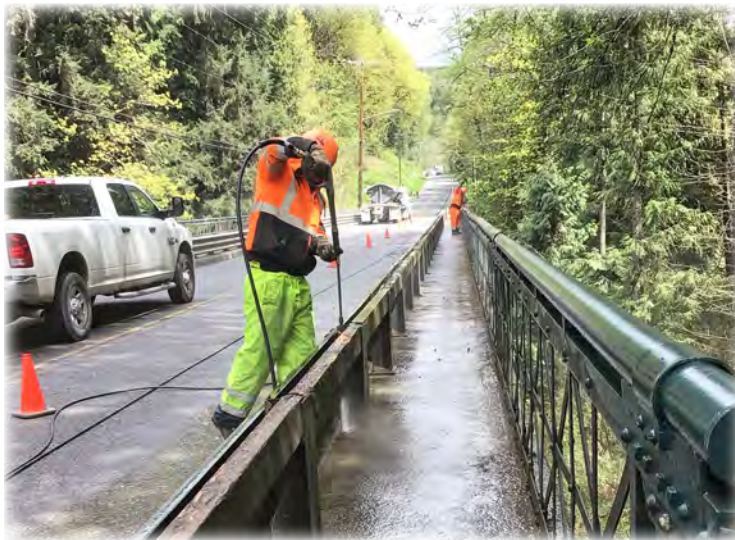
Snohomish County Bridge Maintenance Crew member pressure washing the deck and pedestrian walkway at Granite Falls Bridge 102.

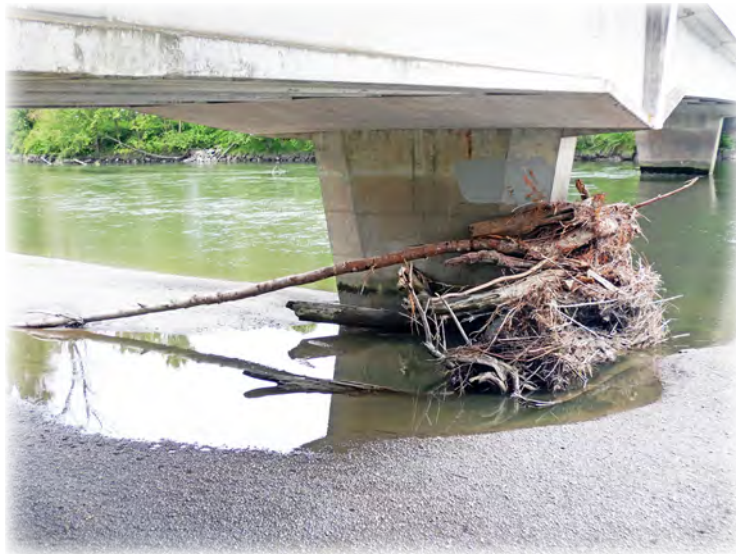
Jim Donner Bridge 4 with a log jam at one of the internal piers due to flood waters. The bridge was built over the Stillaguamish River on Marine Drive in 1985.
