RFQ-24-001TB

PROPERTY CONDITION ASSESSMENT

America's Best Value Inn & Suites
22127 Highway 99
Edmonds, WA 98026

September 6, 2022

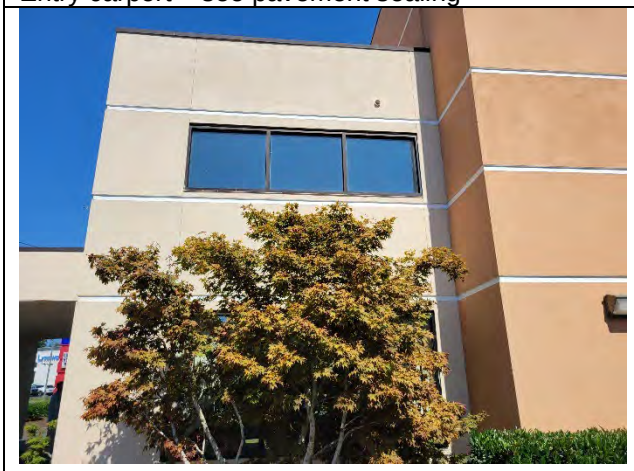
There is landscaping (bushes, trees, ground cover) along the perimeter of the building and on all four sides of the parcel. Although no trees are overhanging the roof, windblown debris from the trees has blocked the roof drains. *We recommend that you continue to trim the building perimeter bushes to ensure they do not contact the building and clean the roof drains of debris.*

Trees and bushes along building perimeter

Maintain bushes and trees so they do not come in contact with the building

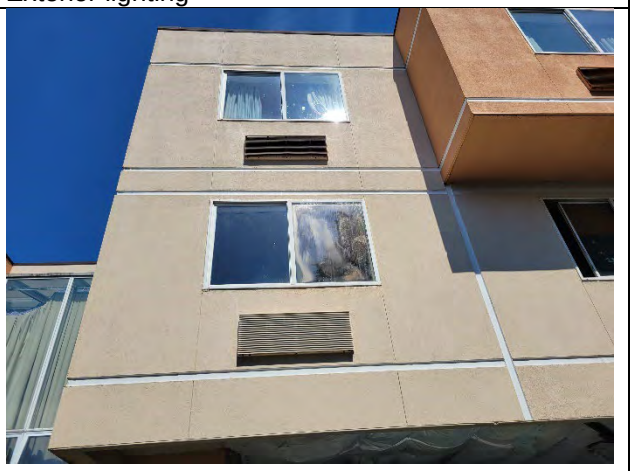
Dual pane window seal leaking – lower right window

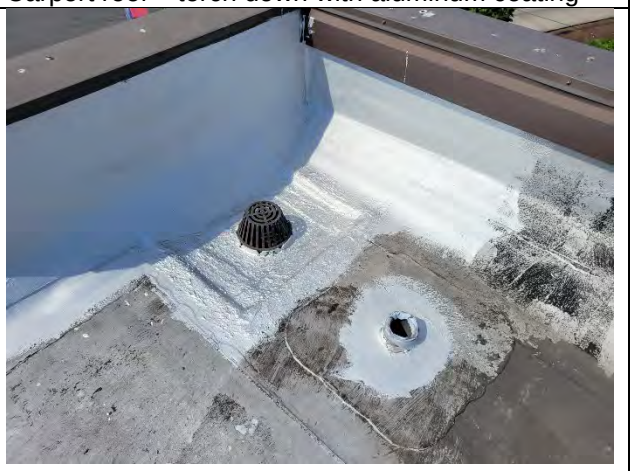
Drain and penetration repairs

Plumbing vent – roof penetration repairs

Bleed out cracking

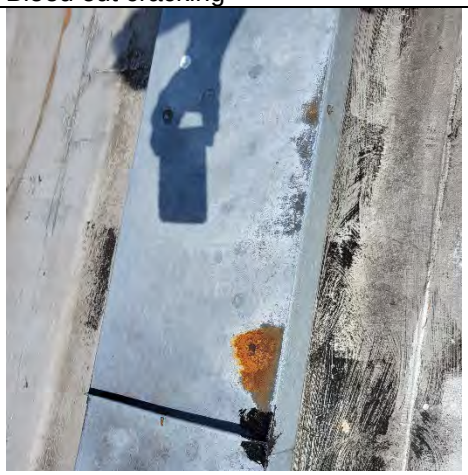
The roof is the original installation (approximately 25 years old) and is a built-up roof (torch down surface), with an applied fibered aluminum roof coating over the 3rd floor roof and carport. The 2nd floor roof (west end of the building) appears to have a granular coated top sheet with a white possibly elastomeric coating (thin coat). *The bleed out of the roof was cracking in numerous areas, there were previous leaks around the roof drains and into the 3rd floor units, the owner has completed previous repairs and is now completing repairs, there are soft spots on the roofs that deflected when stepped upon, and there may not be any rigid insulation beneath the cap sheet. Roofing has an EUL of 20 years. As a result, we recommend the entire roof be replaced (include roof penetrations and coping), rigid insulation be added if required to meet the energy code, and damaged/rotted roof sheathing be replaced. We also recommend the roof/drain/piping connections be observed to ensure they are intact since previous leaks were noted from the internal roof drains.*

Roof cap sheet - lifting

Replace the roof

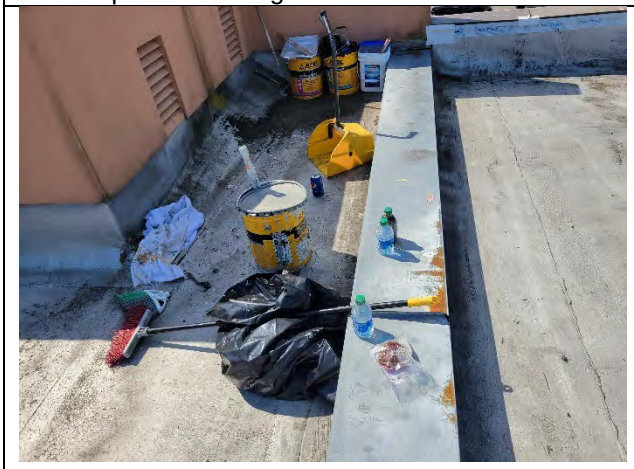
Repair materials

Exhaust fan penetration repairs

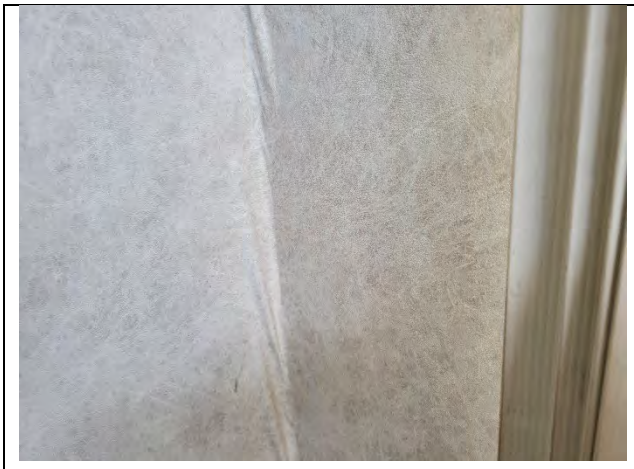
The corridor walls have what appears to be a vinyl wall covering. The wall covering is damaged in areas. Also, the wall covering was either not installed correctly, or is separating from the wall in the lobby possibly due to a heat or moisture buildup. *We recommend repairing these areas and confirming if there may be any moisture beneath the wall covering.*

Wall covering in lobby area

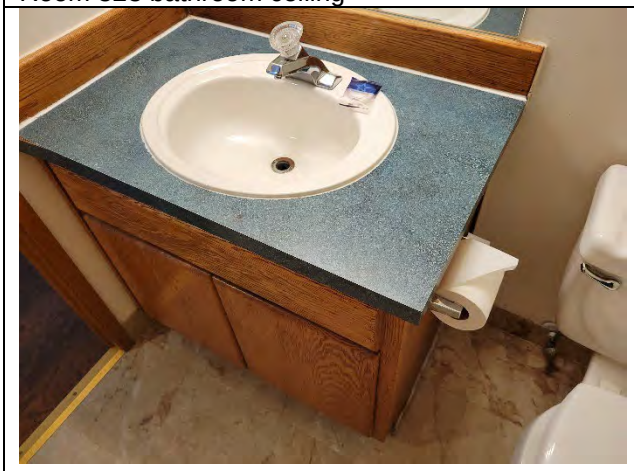
Room 320 bathroom vanity and vinyl flooring

Room 320 PTAC – older model

Note: The individual hotel rooms appeared to be in fair/good condition. We recommend systematically maintaining and replacing room components including flooring, paint and drywall repairs, bathroom fans (included above), bathroom lighting, and proper sealing of the tub/surround/tile should be completed as conditions permit. The PTAC's are replaced upon failure, and they will continue to require replacement.

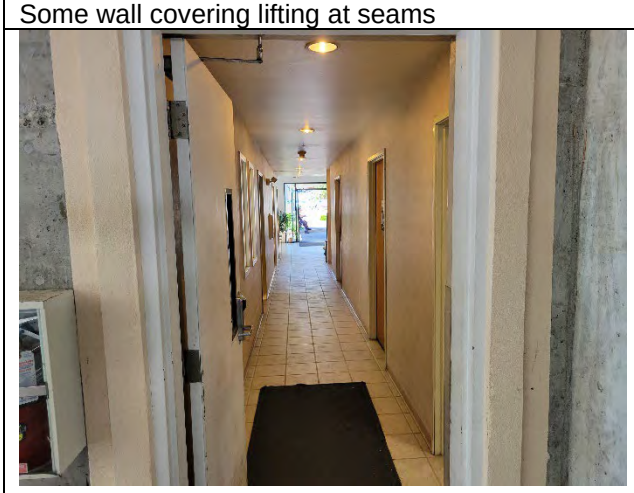
Corridor and stairway flooring is carpet. *A majority of the carpeting is in fair condition and appears to be at or has exceeded its EUL of approximately 5 years. We recommend you plan on systematically replacing*

Worn corridor carpeting

Some wall covering lifting at seams

Some wall covering damage
